**BEFORE THE HON'BLE NATIONAL GREEN TRIBUNAL**  
**SOUTHERN ZONE, CHENNAI.**  
**Original Application No. 180 of 2023 (SZ)**  
**And**  
**Original Application No. 183 of 2023 (SZ)**

SUOMOTU based on the Visual media  
titled Chennai Rains Makkalai Vathaikkum  
Oil Companies-Shocking Story - Michaung  
Ground Report covered by on VIKATAN TV  
Chennai dt.06.12.2023

**REPORT FILED ON BEHALF OF THE RESPONDENT -  
TAMIL NADU POLLUTION CONTROL BOARD**

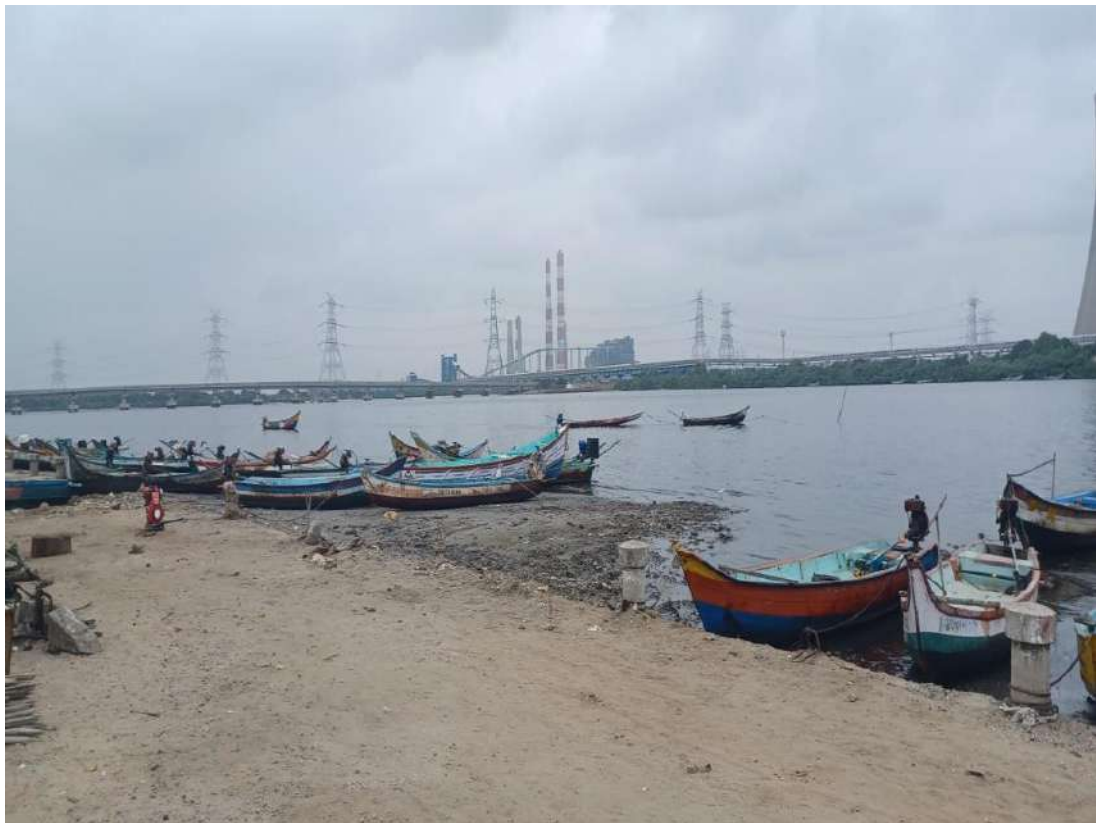
**Thalankuppam Stretch before Cleaning**

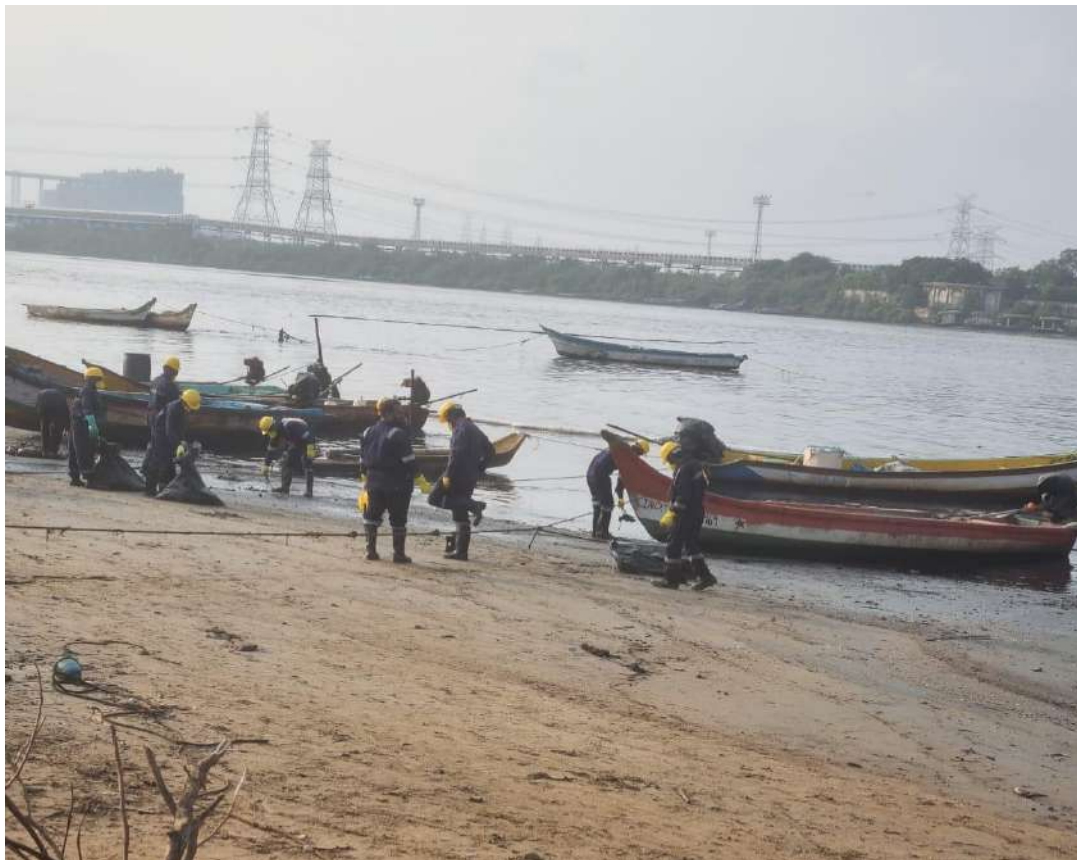
**Nettukuppam Stretch before Cleaning**

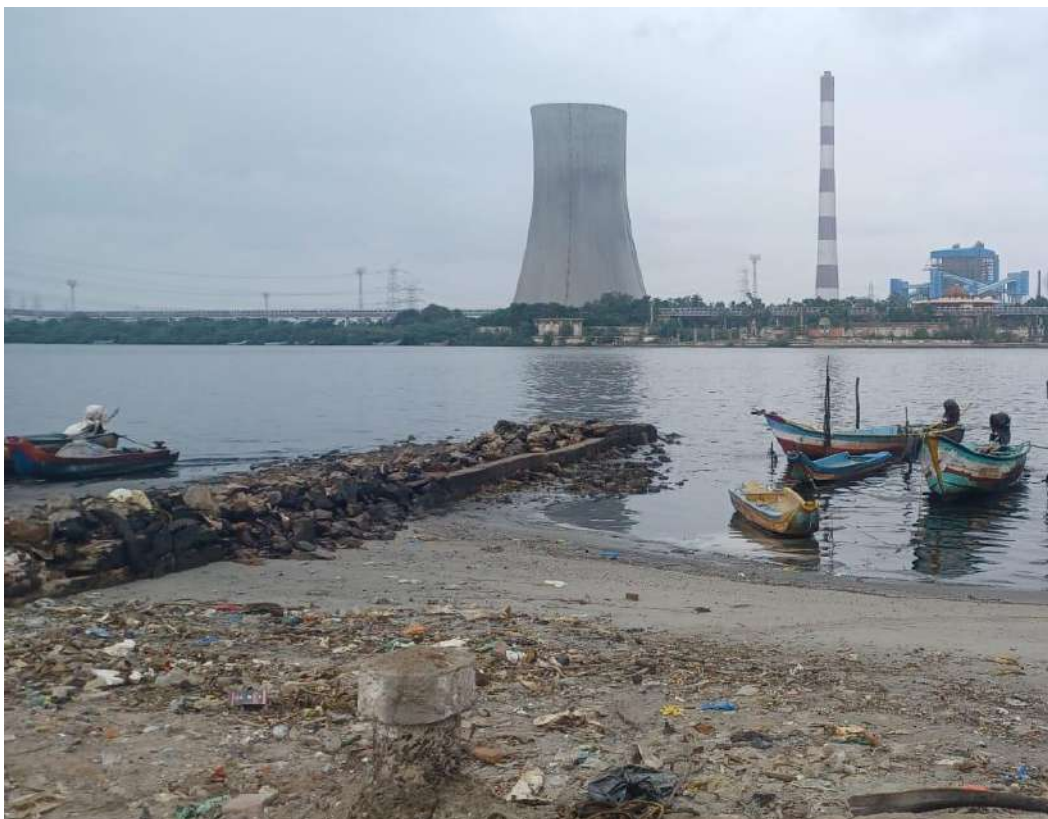
**Ennorekuppam Stretch before Cleaning**

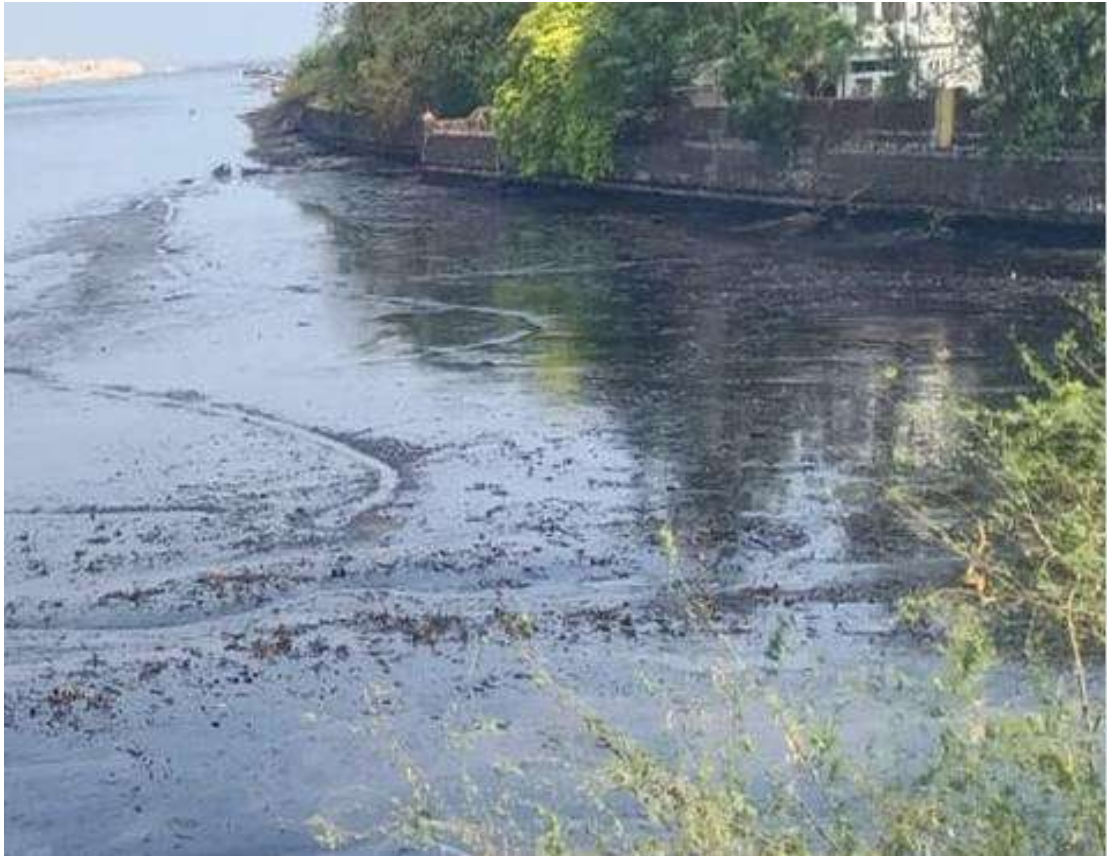
**Ennorekuppam Stretch after Cleaning**

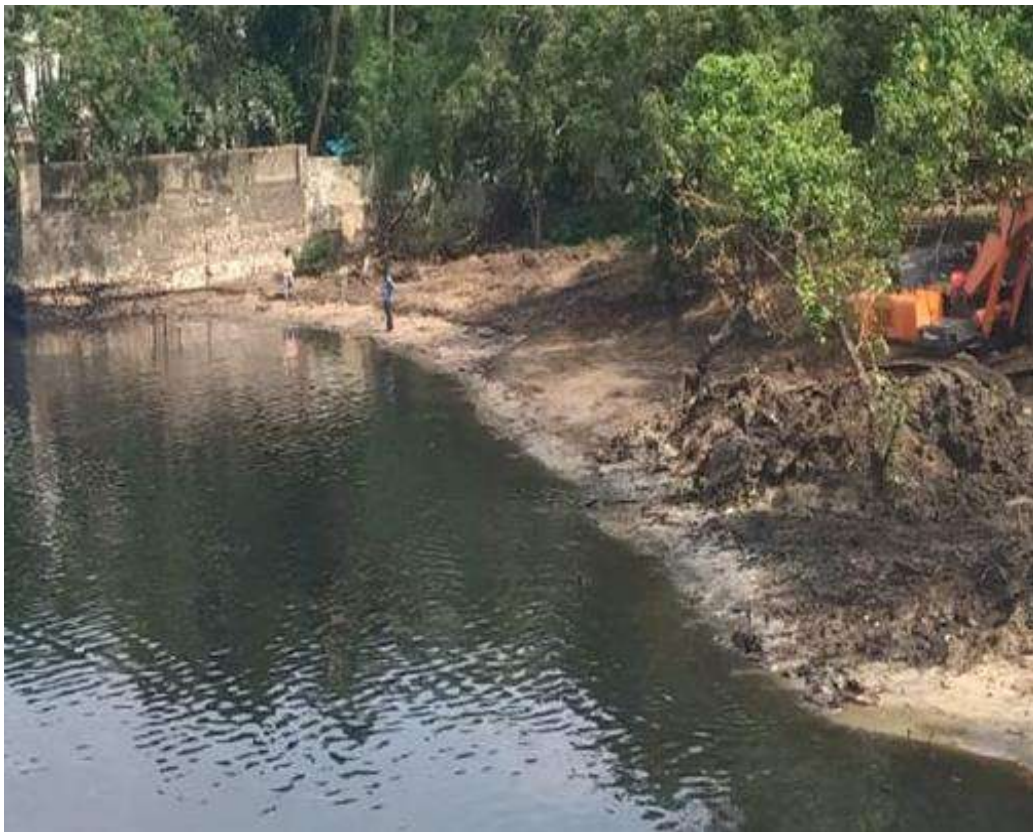
**Ennore Bridge - Right Side before Cleaning**

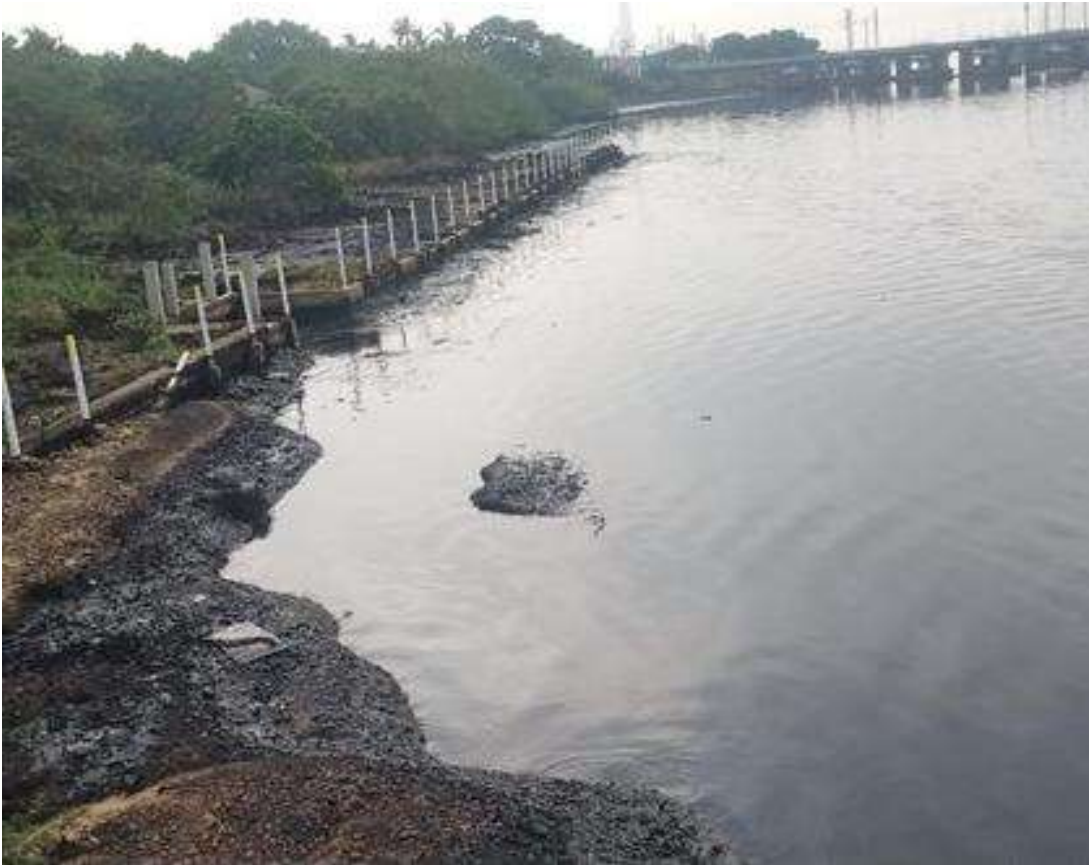
**Ennore Bridge - Right Side after Cleaning**

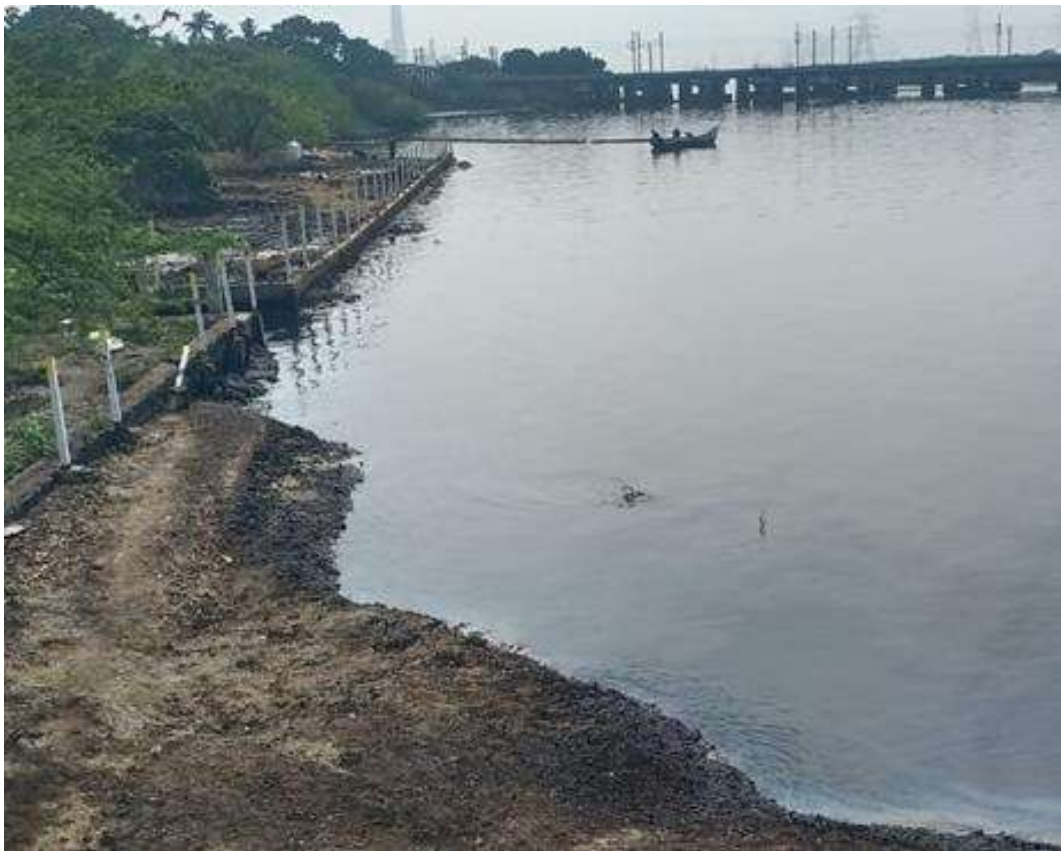
**Ennore Bridge - Left Side before Cleaning**

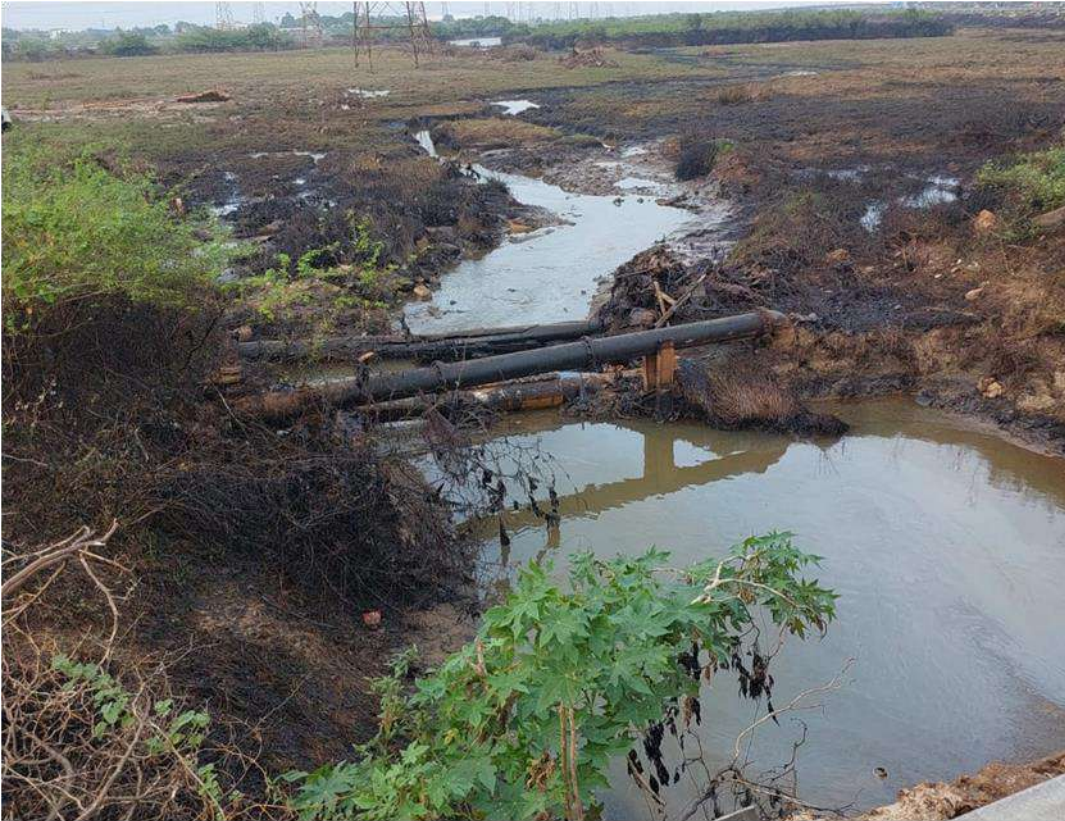
**Ennore Bridge - Left Side after Cleaning**

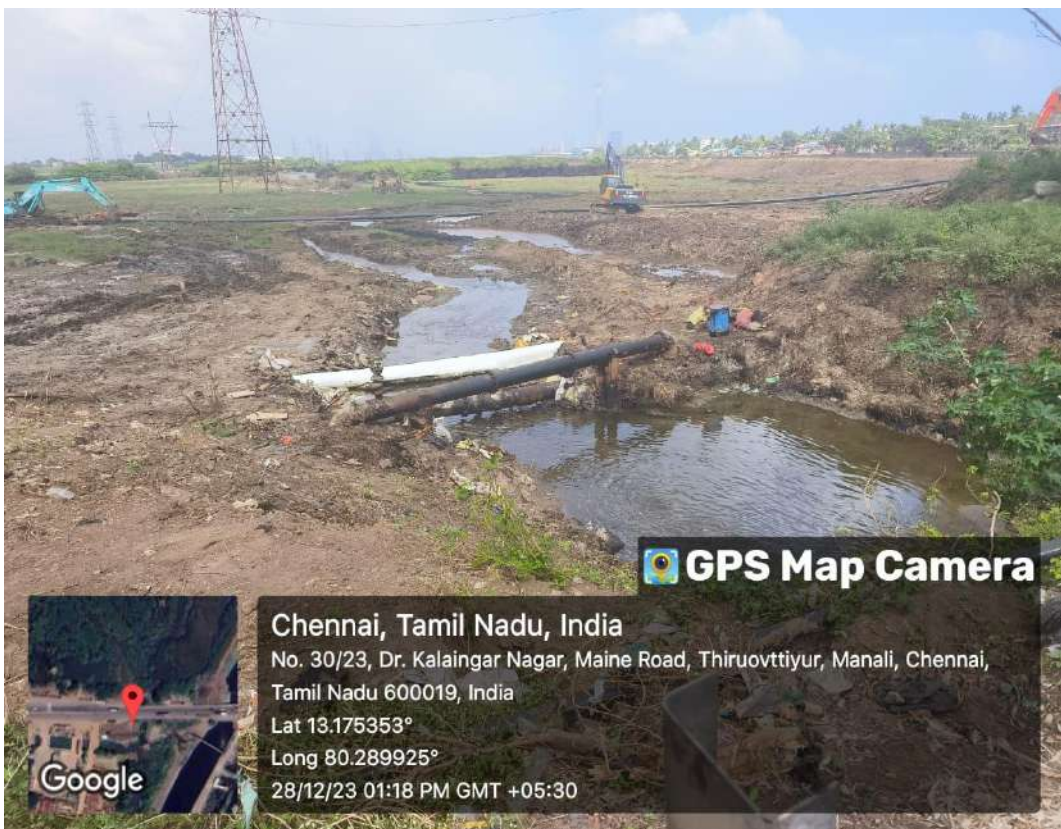
**Sathyamoorthy Nagar before Cleaning**

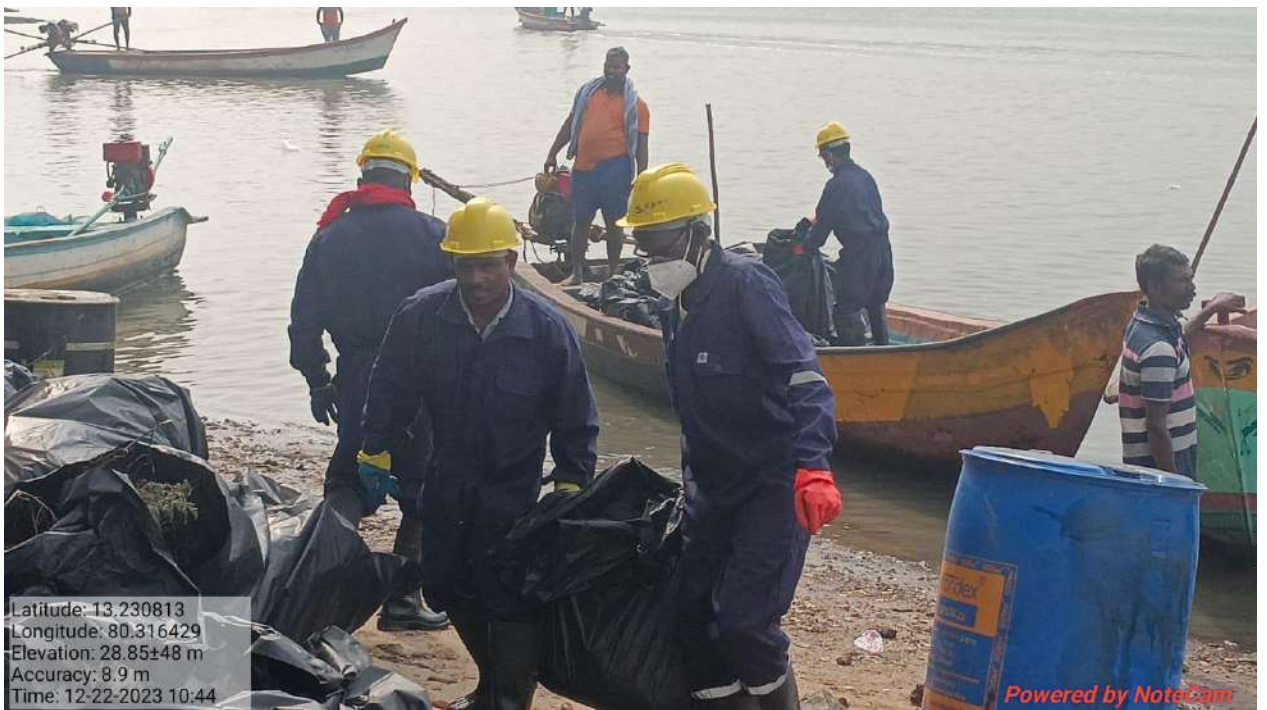
**Shifting of collected oil waste materials in bags at Mugathuvara Kuppam**

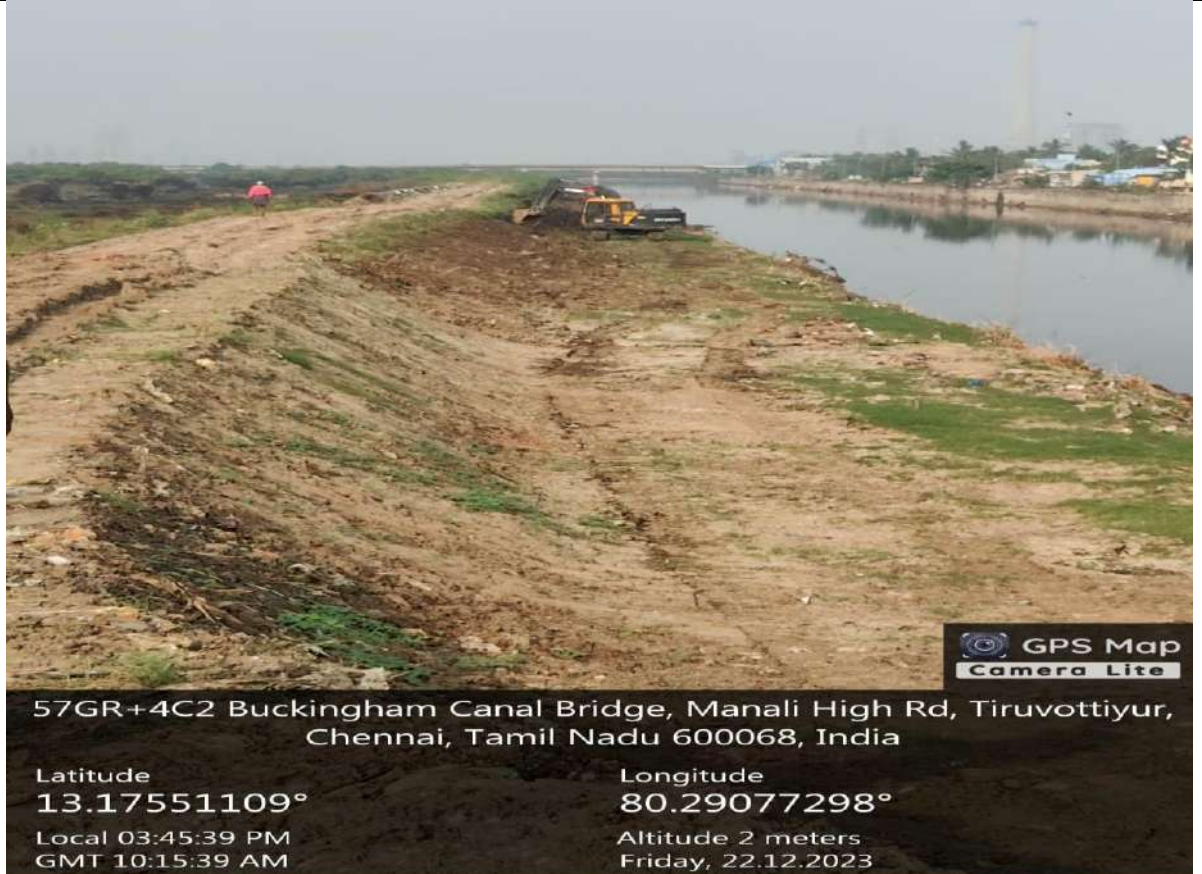
**Machineries are deployed in cleaning activity at Sathyamurthy Nagar stretch**

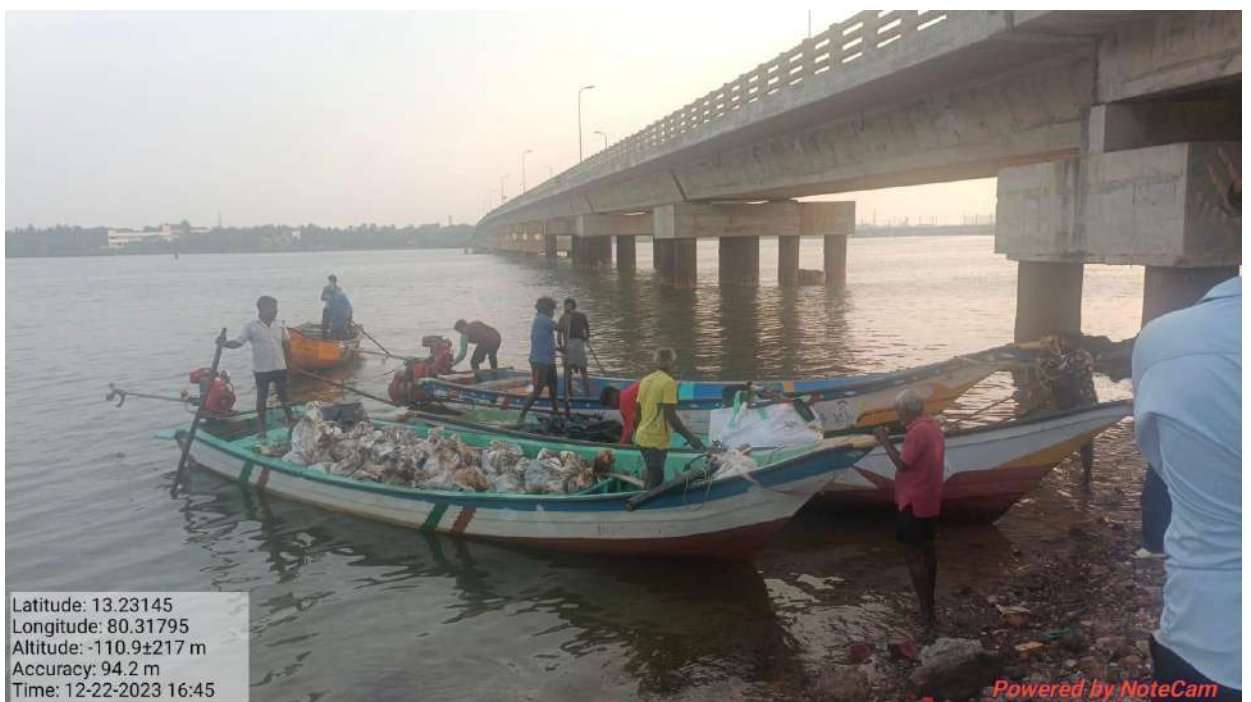
**Receiving of bags containing oil affected materials in boats at Mugathuvara Kuppam**

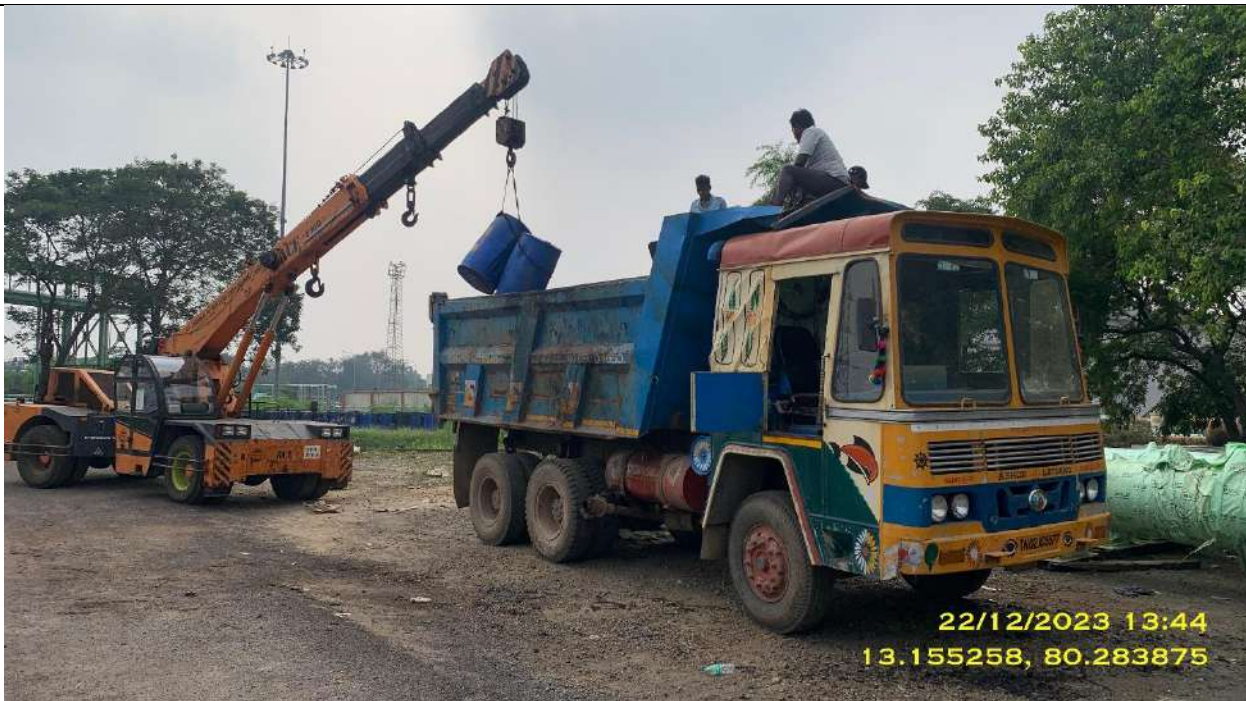
**Unloading of barrels containing oily water in CPCL premises**

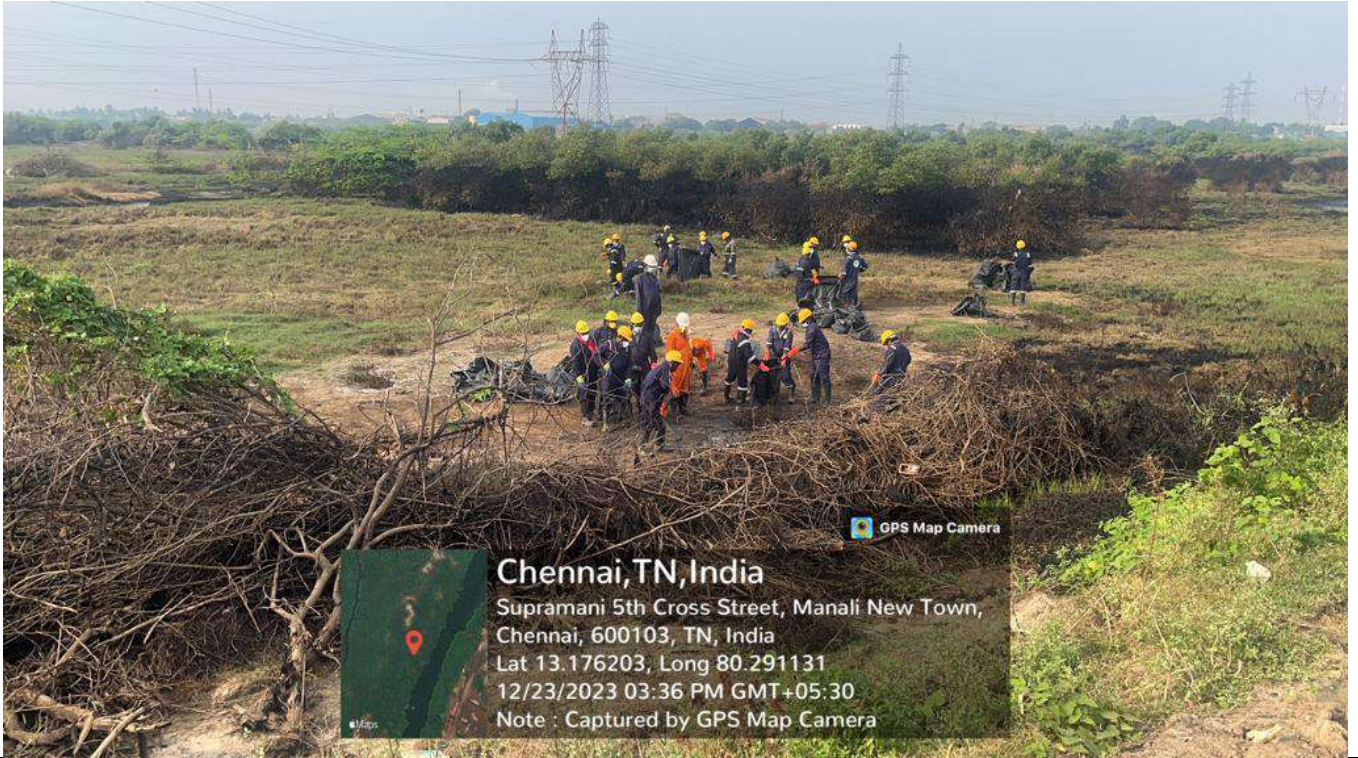
**Removal of plants and debris affected by the oil near Sathyamurthy Nagar**

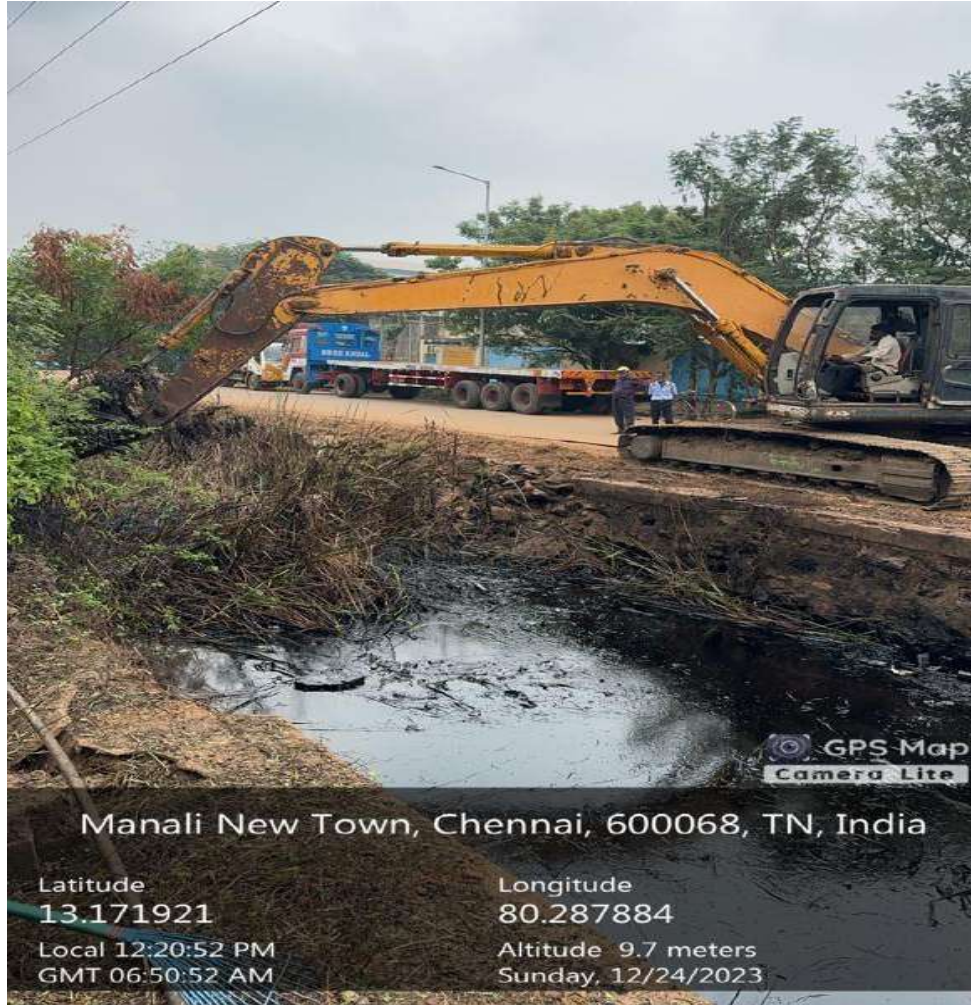
**Cleaning activities carried out through Poclain at CMDA Steel yard area**

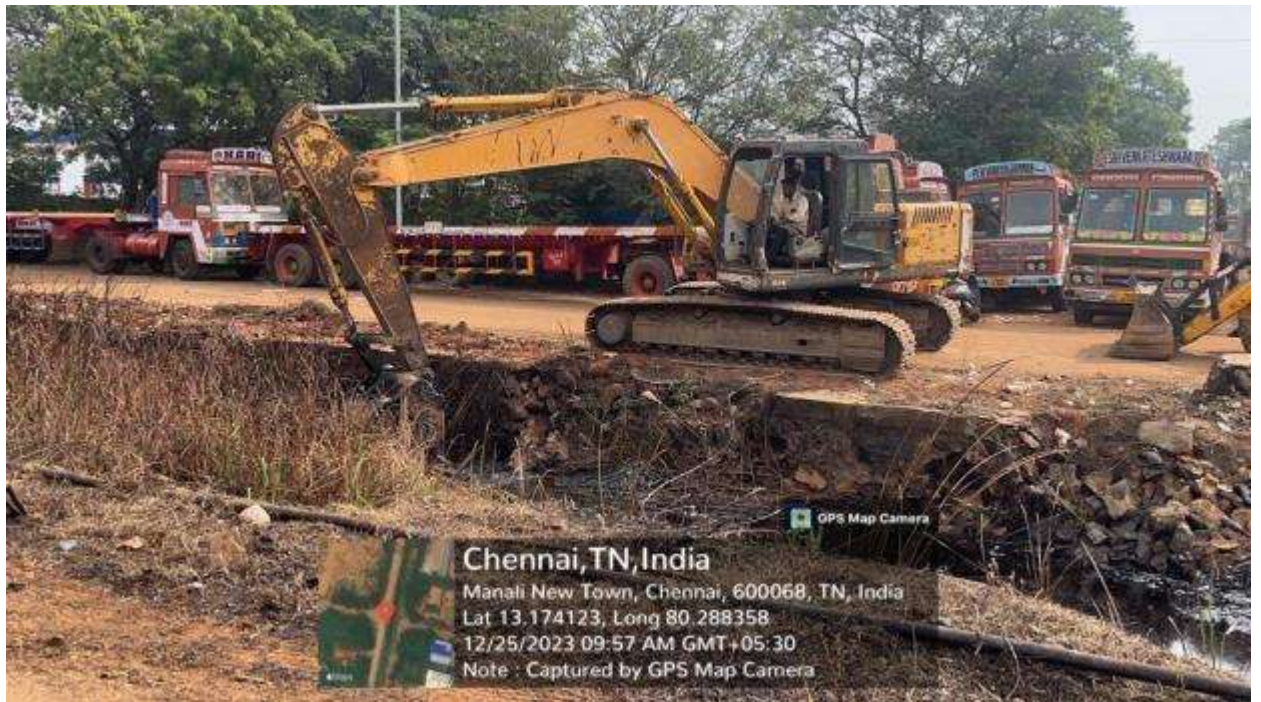
**Cleaning activities carried out through Poclaim at CMDA Steel yard area**

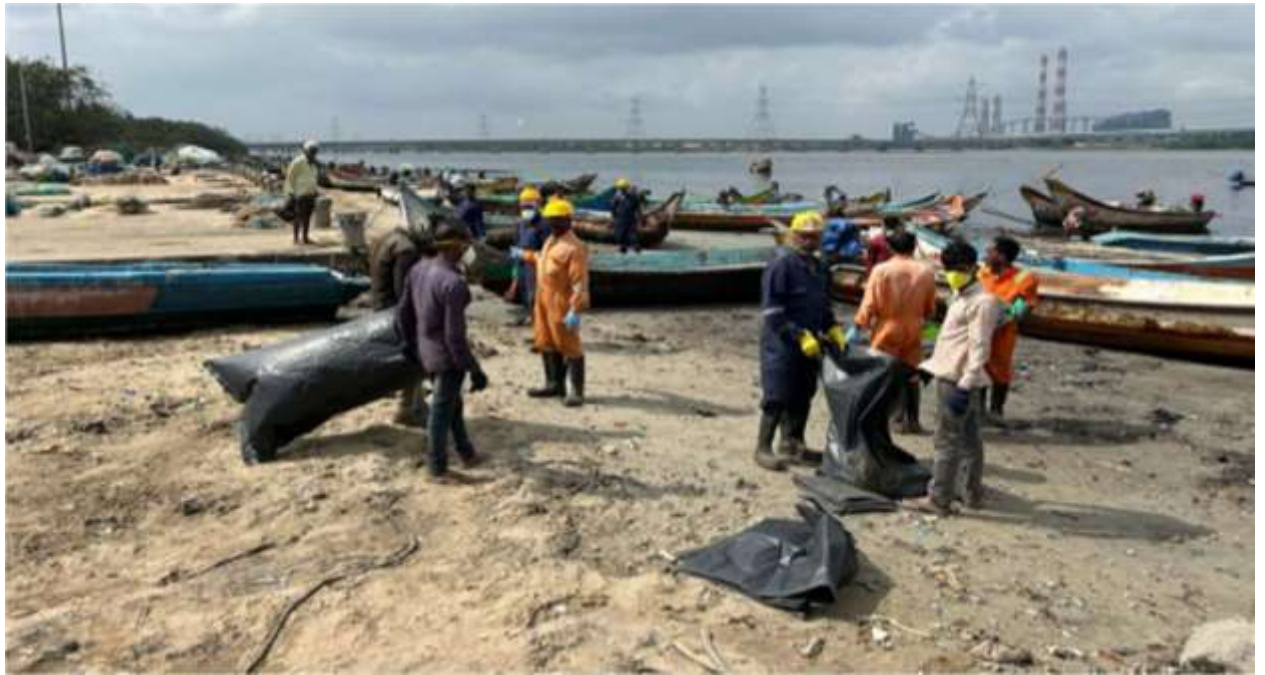
**Cleaning activities in progress at Nettu Kuppam and Ennore Kuppam area**

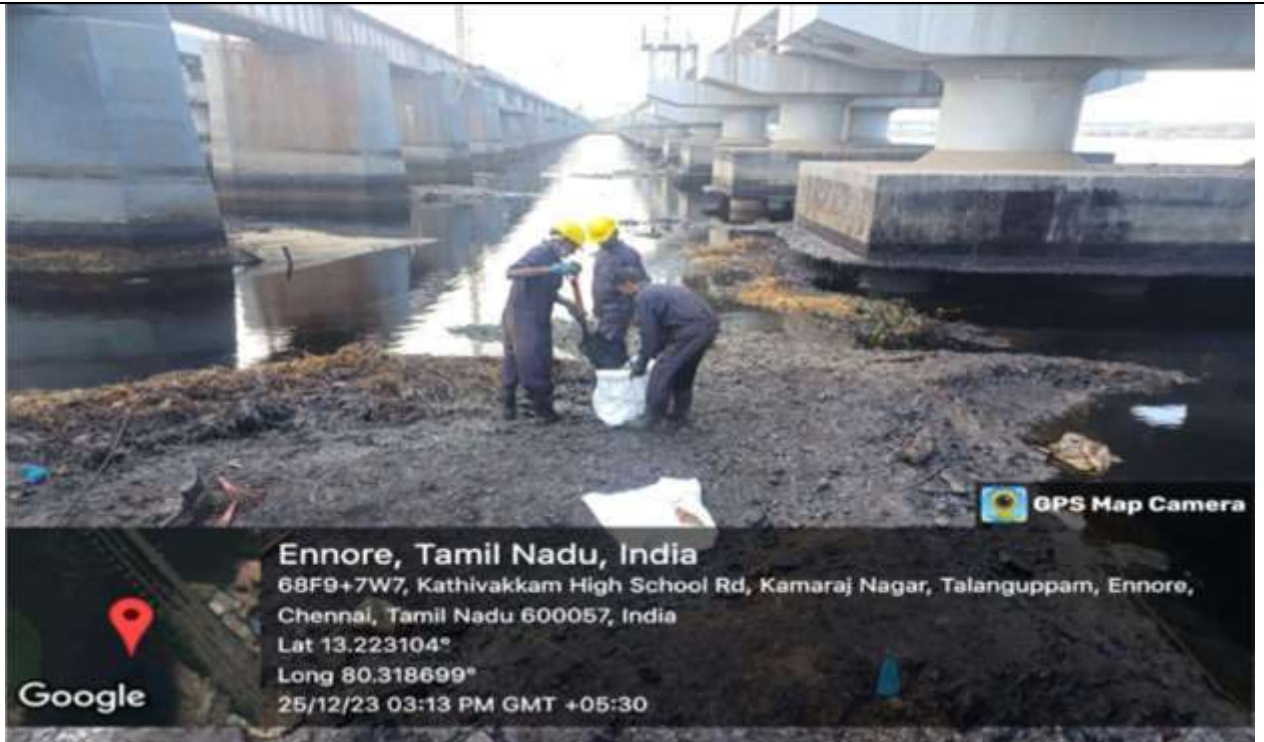
**Cleaning activities in progress under Ennore Railway Bridge**

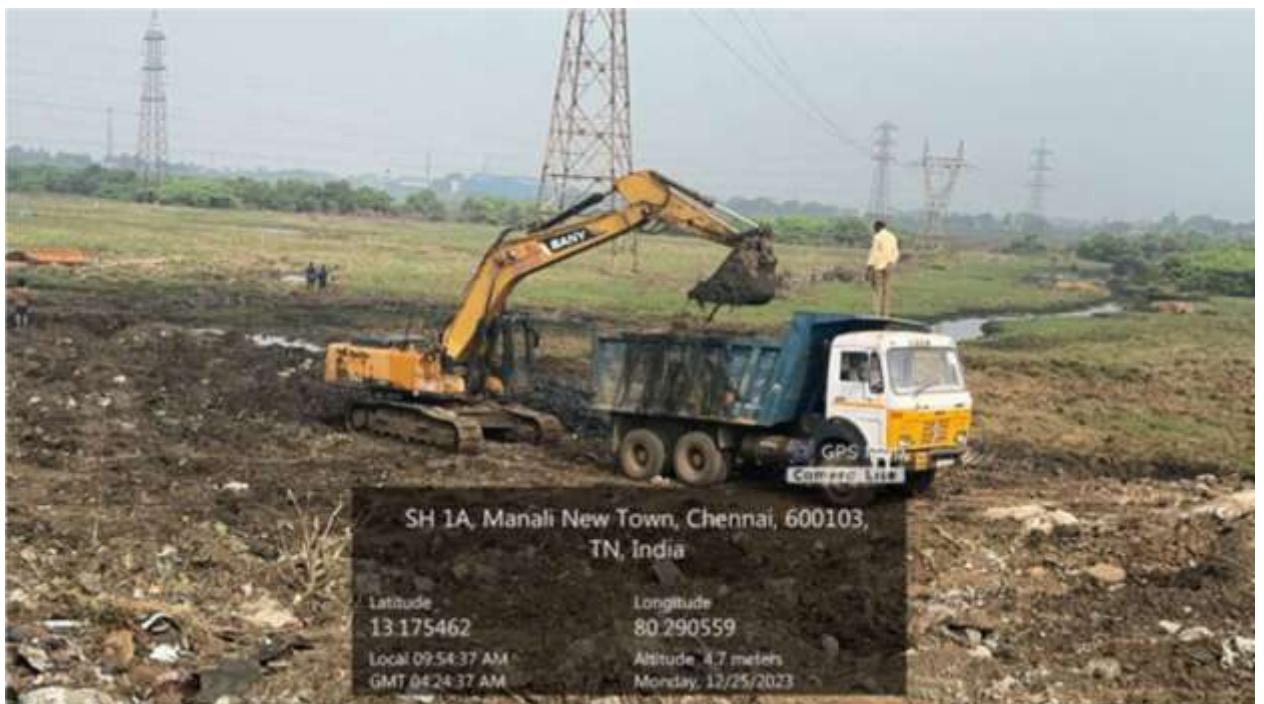
**Removal of soil and debris affected by the oil through Poclairn near Sathyamurthy Nagar**

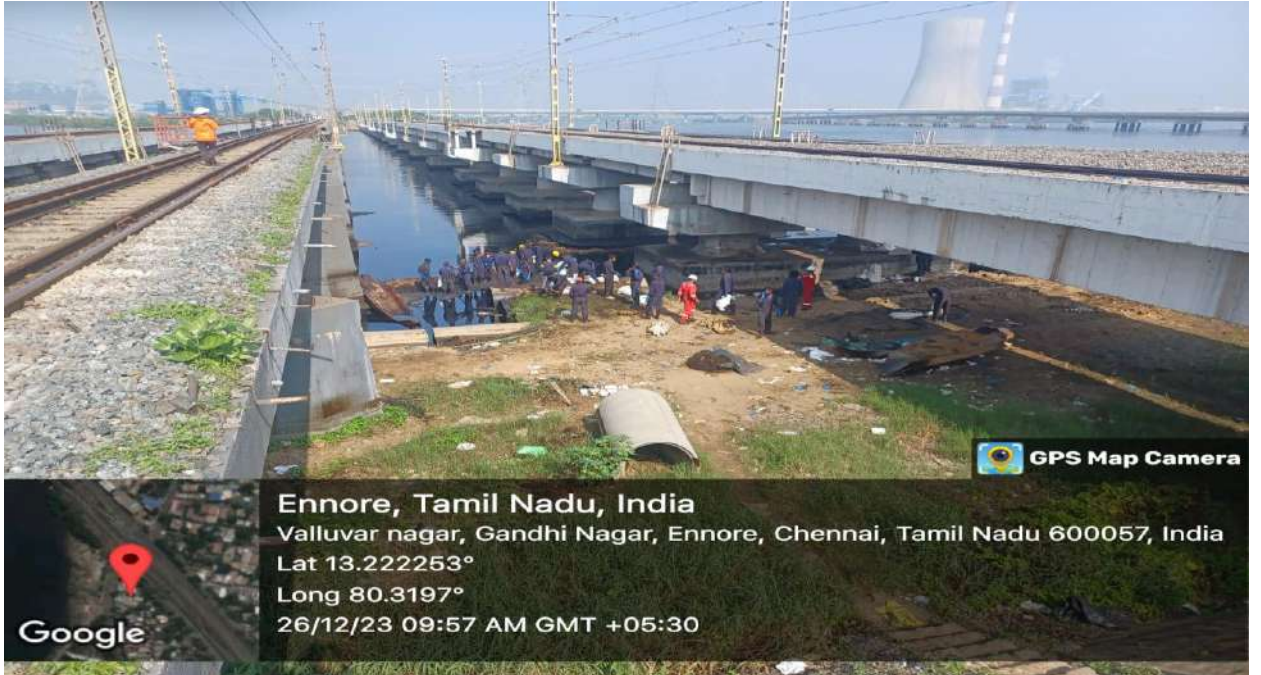
**Removal of oily water and debris by manually below the ennore railway bridge:**

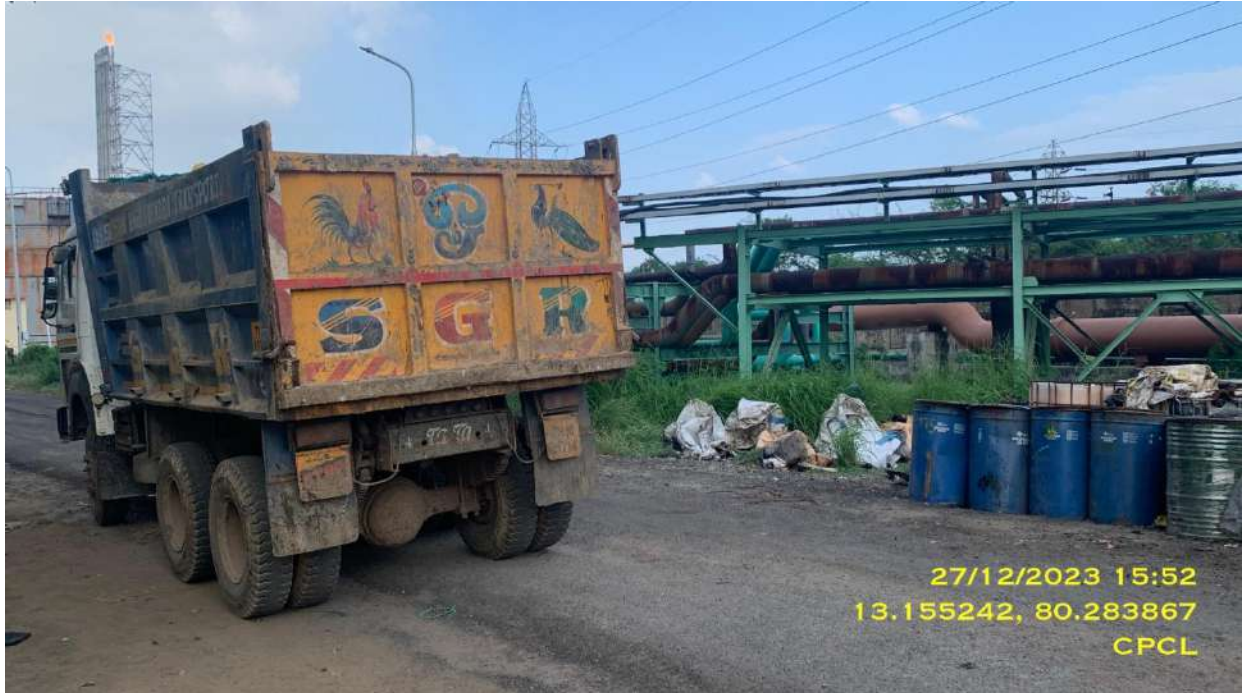
**Unloading of barrels containing collected oily water within the CPCL premises**

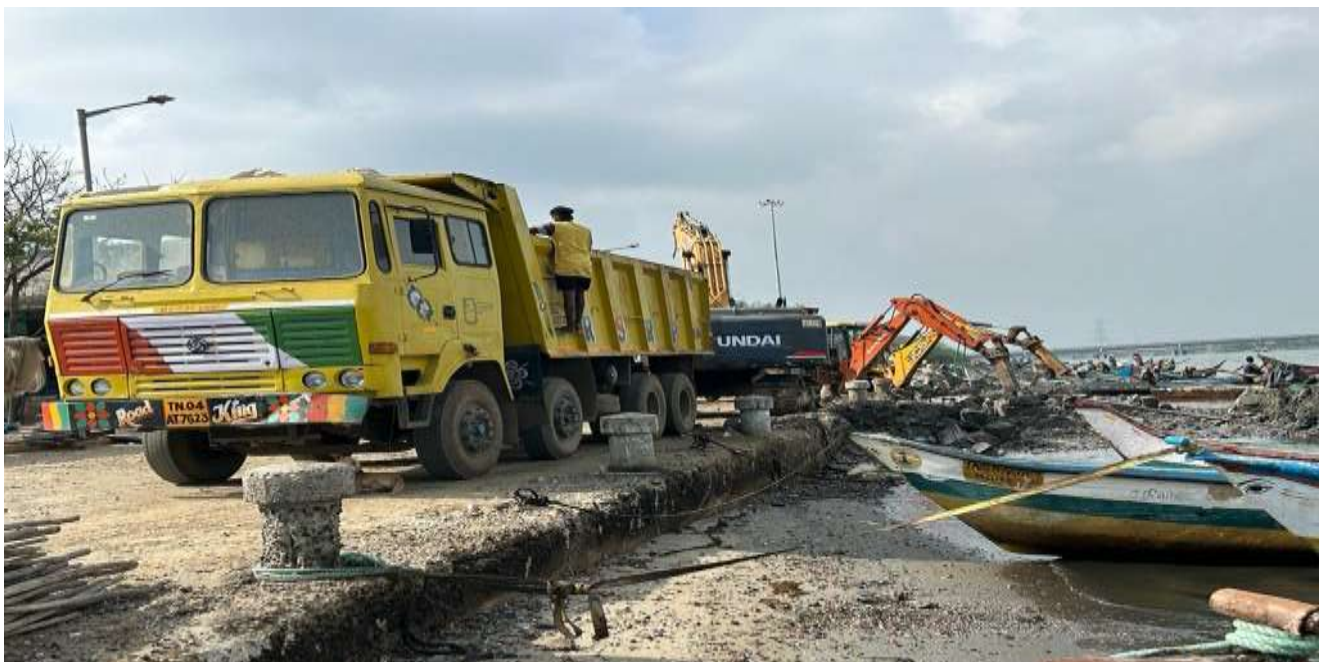
**Removal and loading of boulders in the shore line by using machineries such as poclain and breaker at Nettu kuppam and Mukathuvarakuppam area**

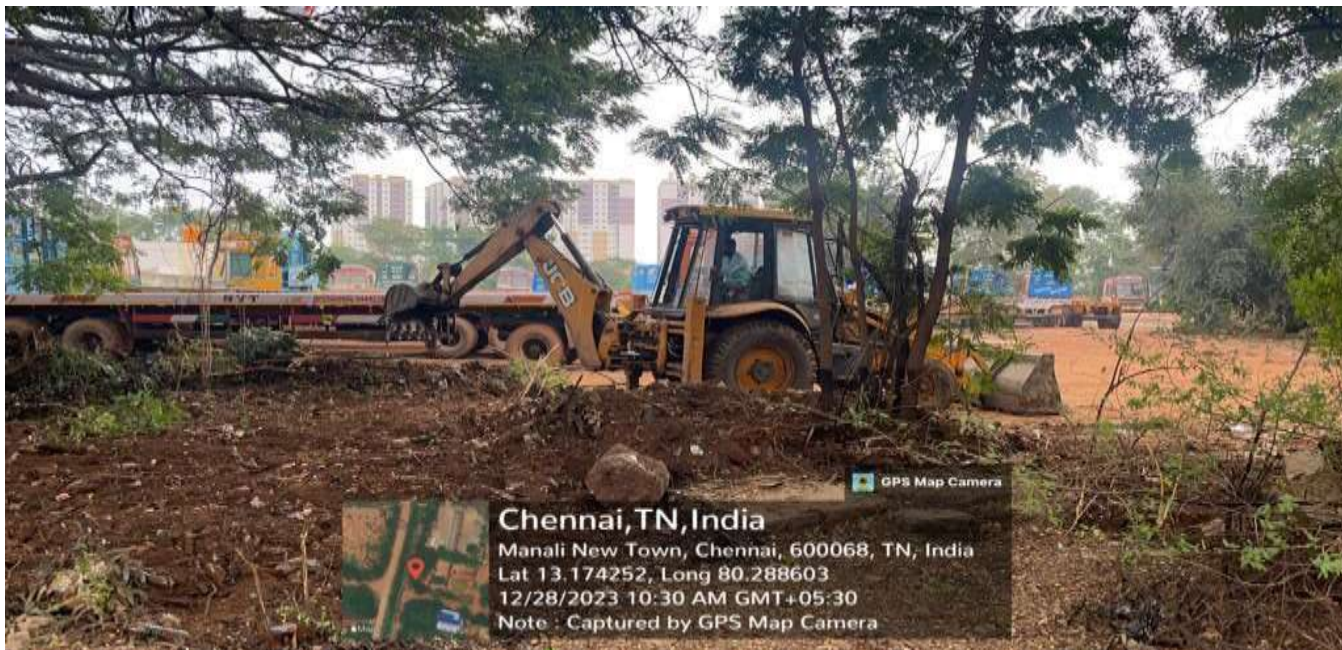
**Cleaning work in progress by using JCB at at CMDA Steel yard area**

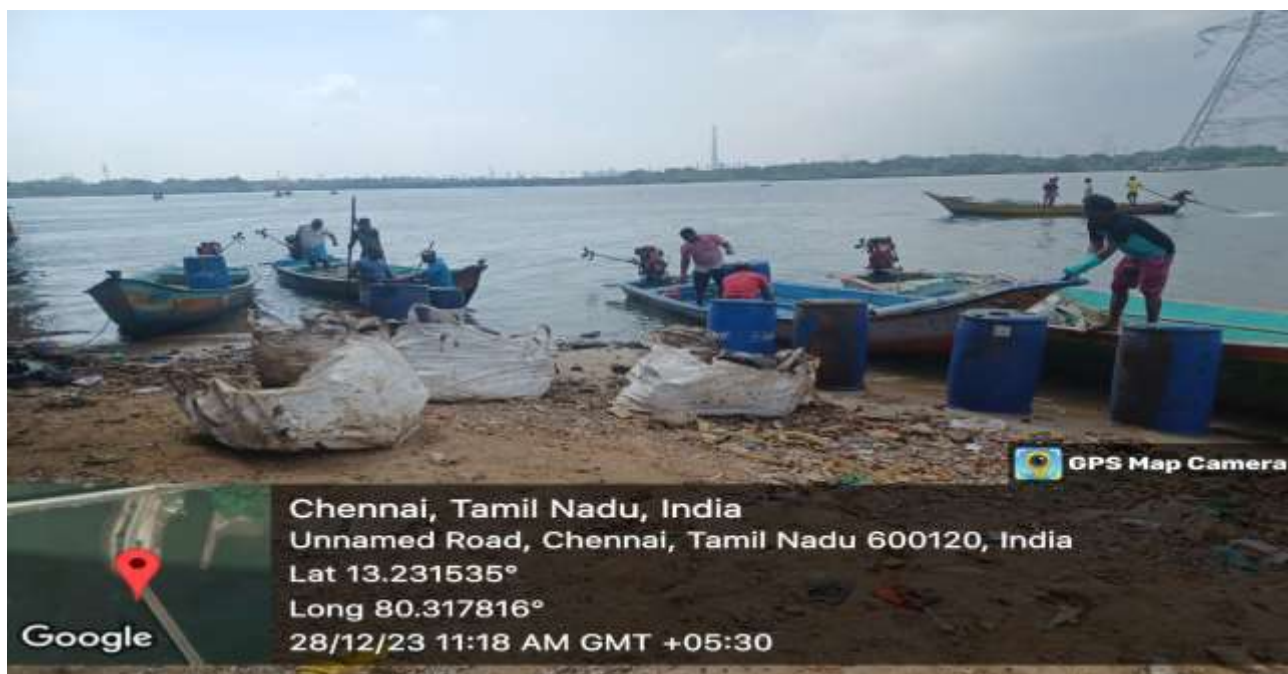
**Unloading of barrels and bags containing oily materials from boats at ennore mugathuvaram bridge**

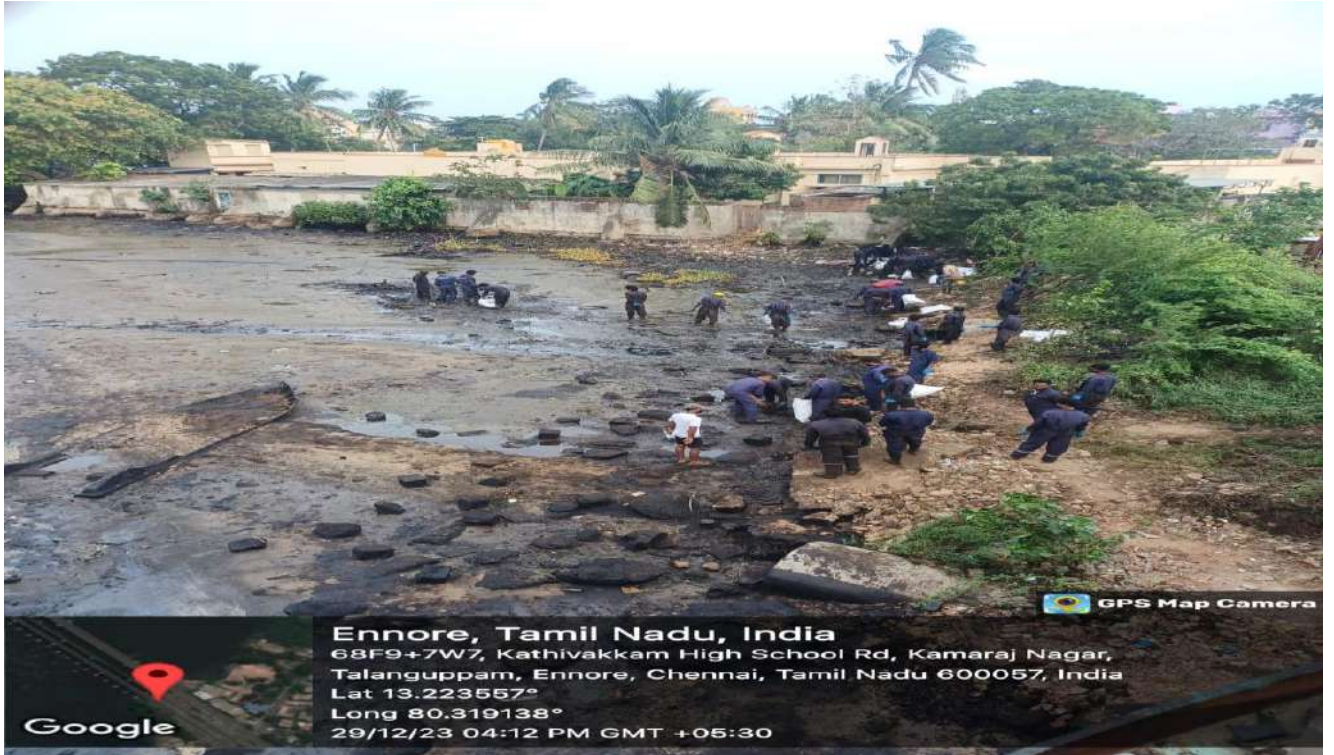
**Cleaning work in progress under Ennore Railway Bridge**
