**BEFORE THE HON'BLE NATIONAL GREEN TRIBUNAL**  
**SOUTHERN ZONE, CHENNAI.**  
**Original Application No. 180 of 2023 (SZ)**  
**And**  
**Original Application No. 183 of 2023 (SZ)**

SUOMOTU based on the Visual media  
titled Chennai Rains Makkalai Vathaikkum  
Oil Companies-Shocking Story - Michaung  
Ground Report covered by on VIKATAN TV  
Chennai dt.06.12.2023

**REPORT FILED ON BEHALF OF THE RESPONDENT -  
TAMIL NADU POLLUTION CONTROL BOARD**

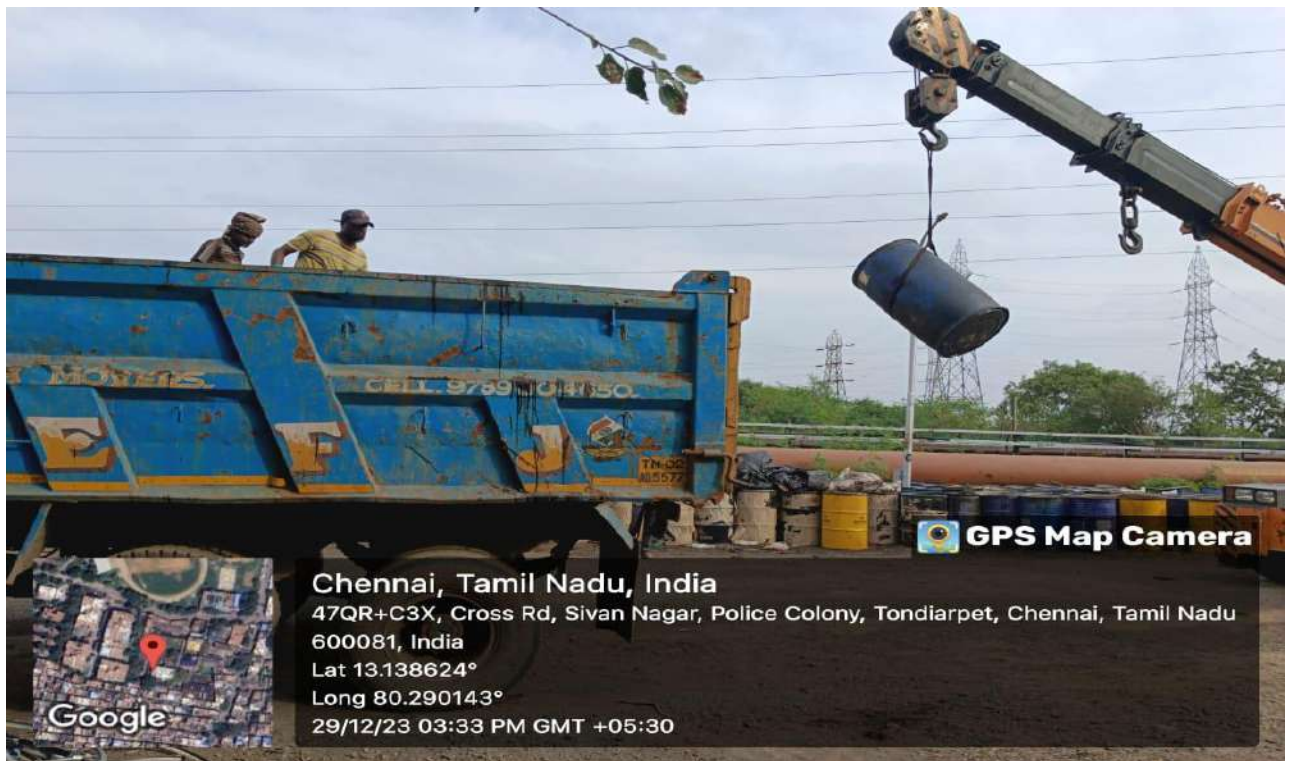
**Unloading of barrels containing oily water within the CPCL premises**

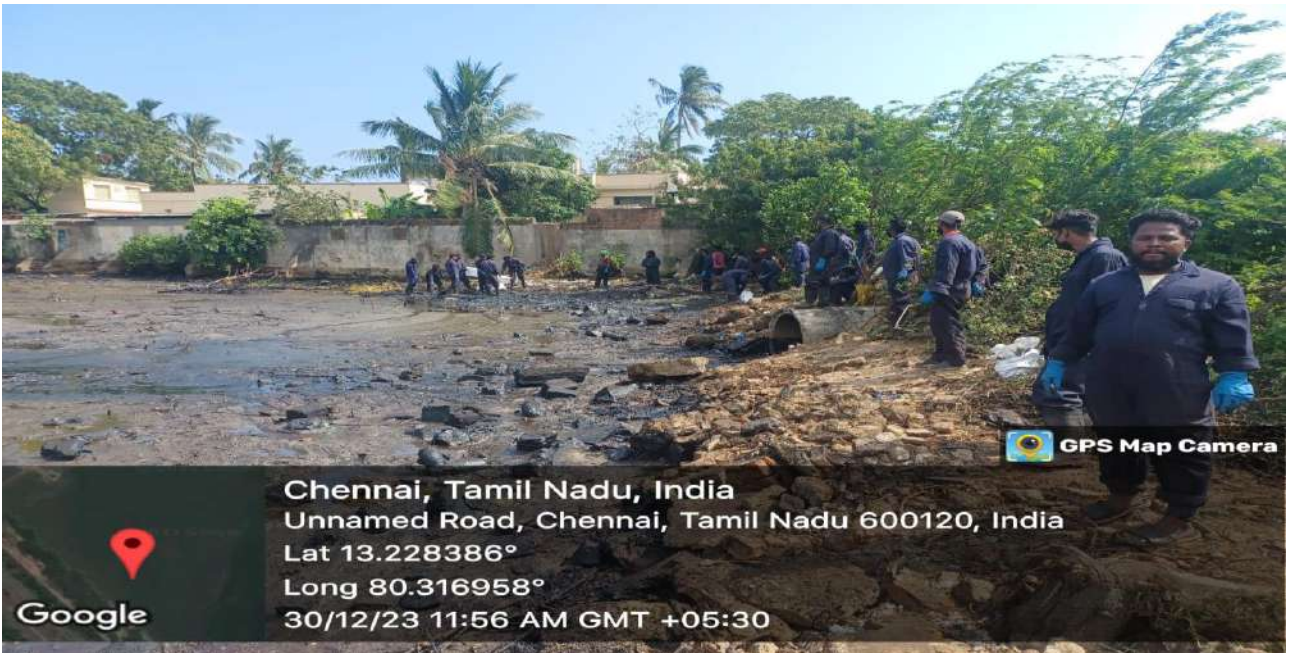
**Cleaning and removal of debris manually under Ennore Railway Bridge**

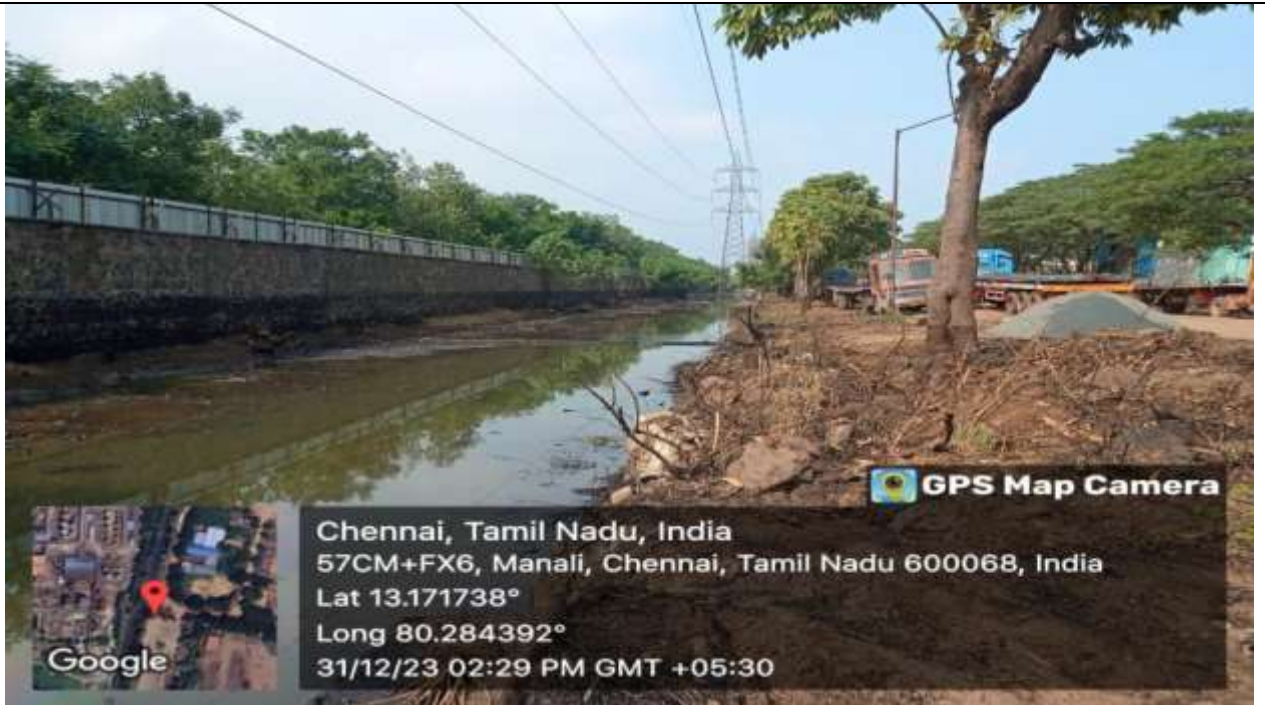
**Cleared area along the canal near Indian Additives compound wall in CMDA Steel complex in Sathankadu.**

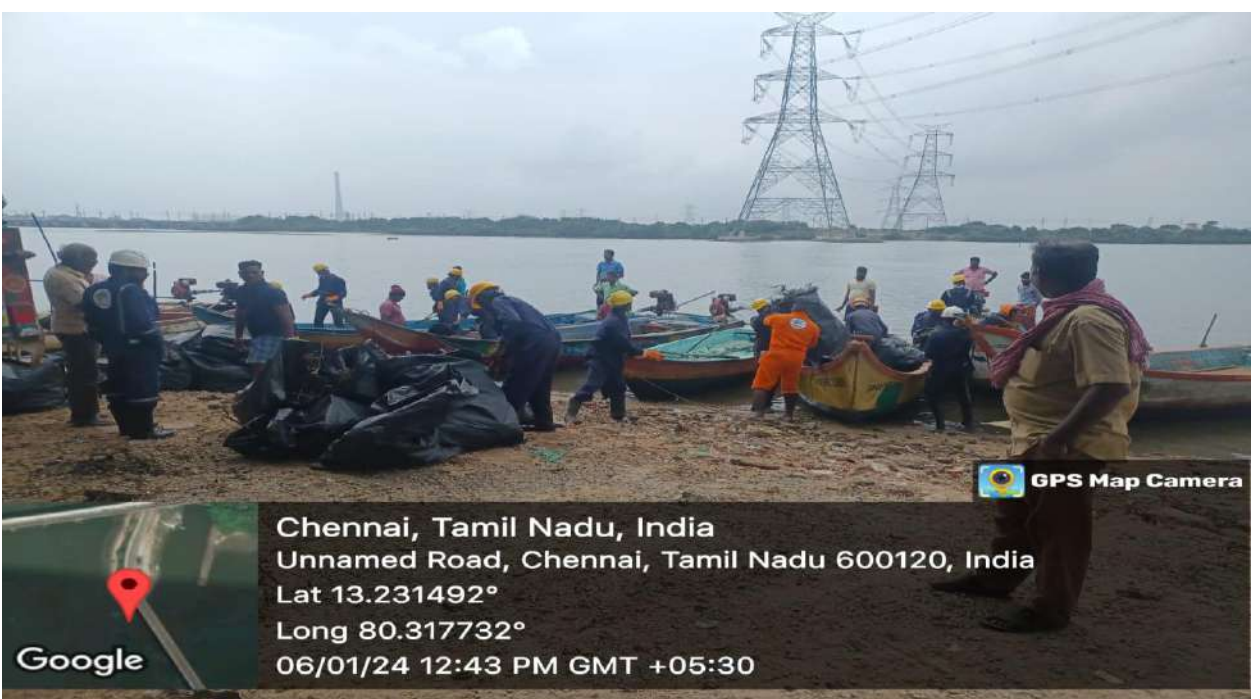
**Bags containing oil affected plant debris was received at Mugathuvara Kuppam and loaded in the truck and sent to CPCL premises**
