DRAFT ENVIRONMENTAL IMPACT ASSESSMENT REPORT OF PROPOSED IRRIGATION PROJECT BY CONSTRUCTION OF BARRAGE WITH HEAD SLUICES

SECTOR 1(C) - RIVER VALLEY/IRRIGATION PROJECTS
CATEGORY - B1

LOCATION OF BARRAGE

Across the River Coleroon at RD 74/3 Mile

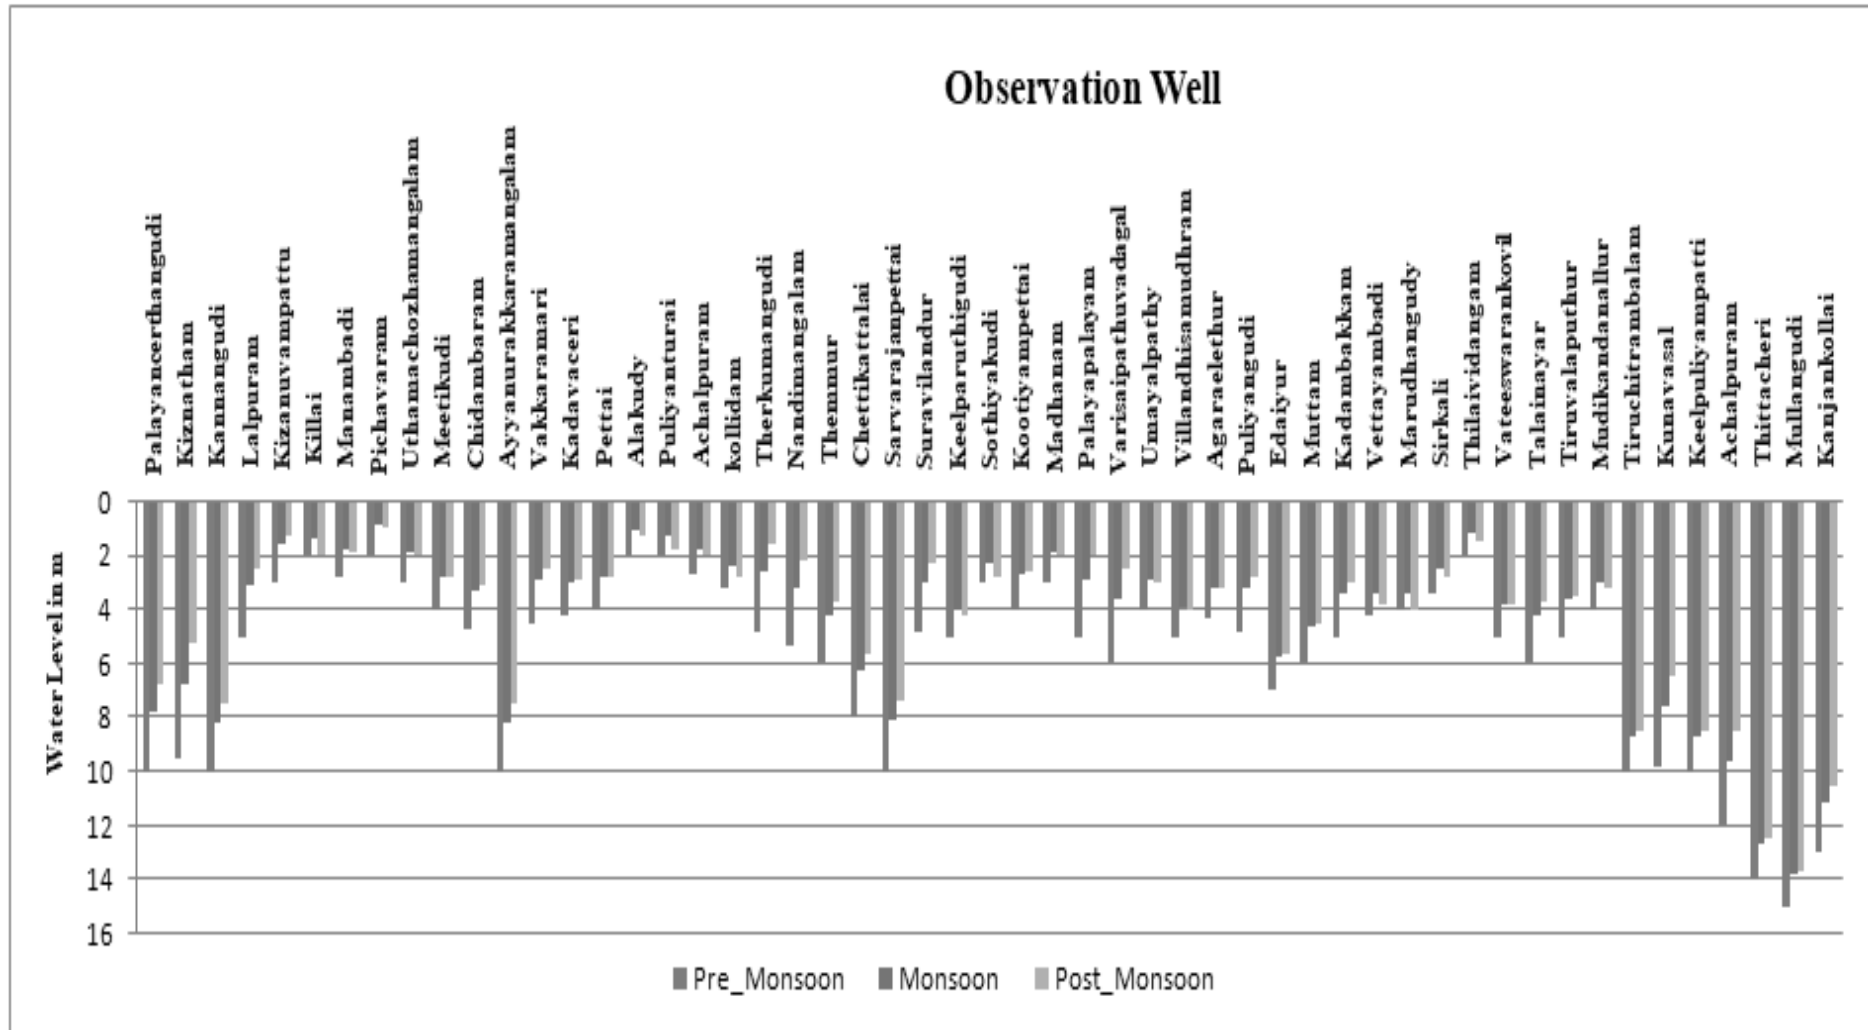
Fig No 3.23 Seasonal variation water level data of Pre monsoon and post monsoon

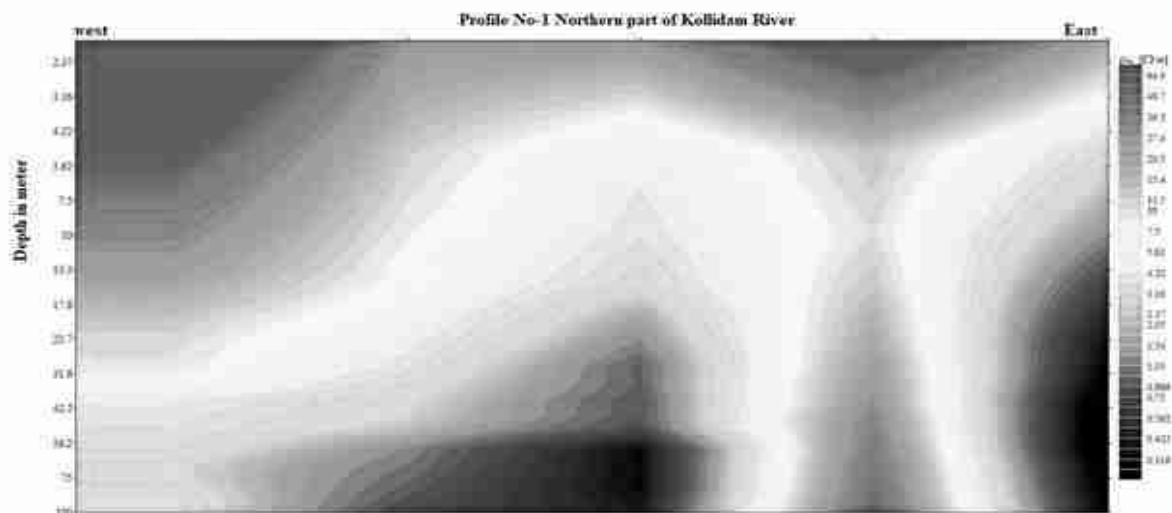
In the profile-1, (North part of Kollidam river) and profile-2, (Souther part of Kollidam river), the resistivity varied from less than 1 Ohm-m to about 100 Ohm-m. The high resistivity value is observed in top layer with 2m to 4m thickness due to the dry soil condition. where high resistivity of above 50 Ohm-m was observed in the top and it gradually decreases to less than 10 Ohm-m noticed due to presence of saline water and sandyclay formation, where 20 Ohm m to 60 Ohm m due presence of sand stone formation.

Figure No 3.38 Pseudo Section of Profile-1

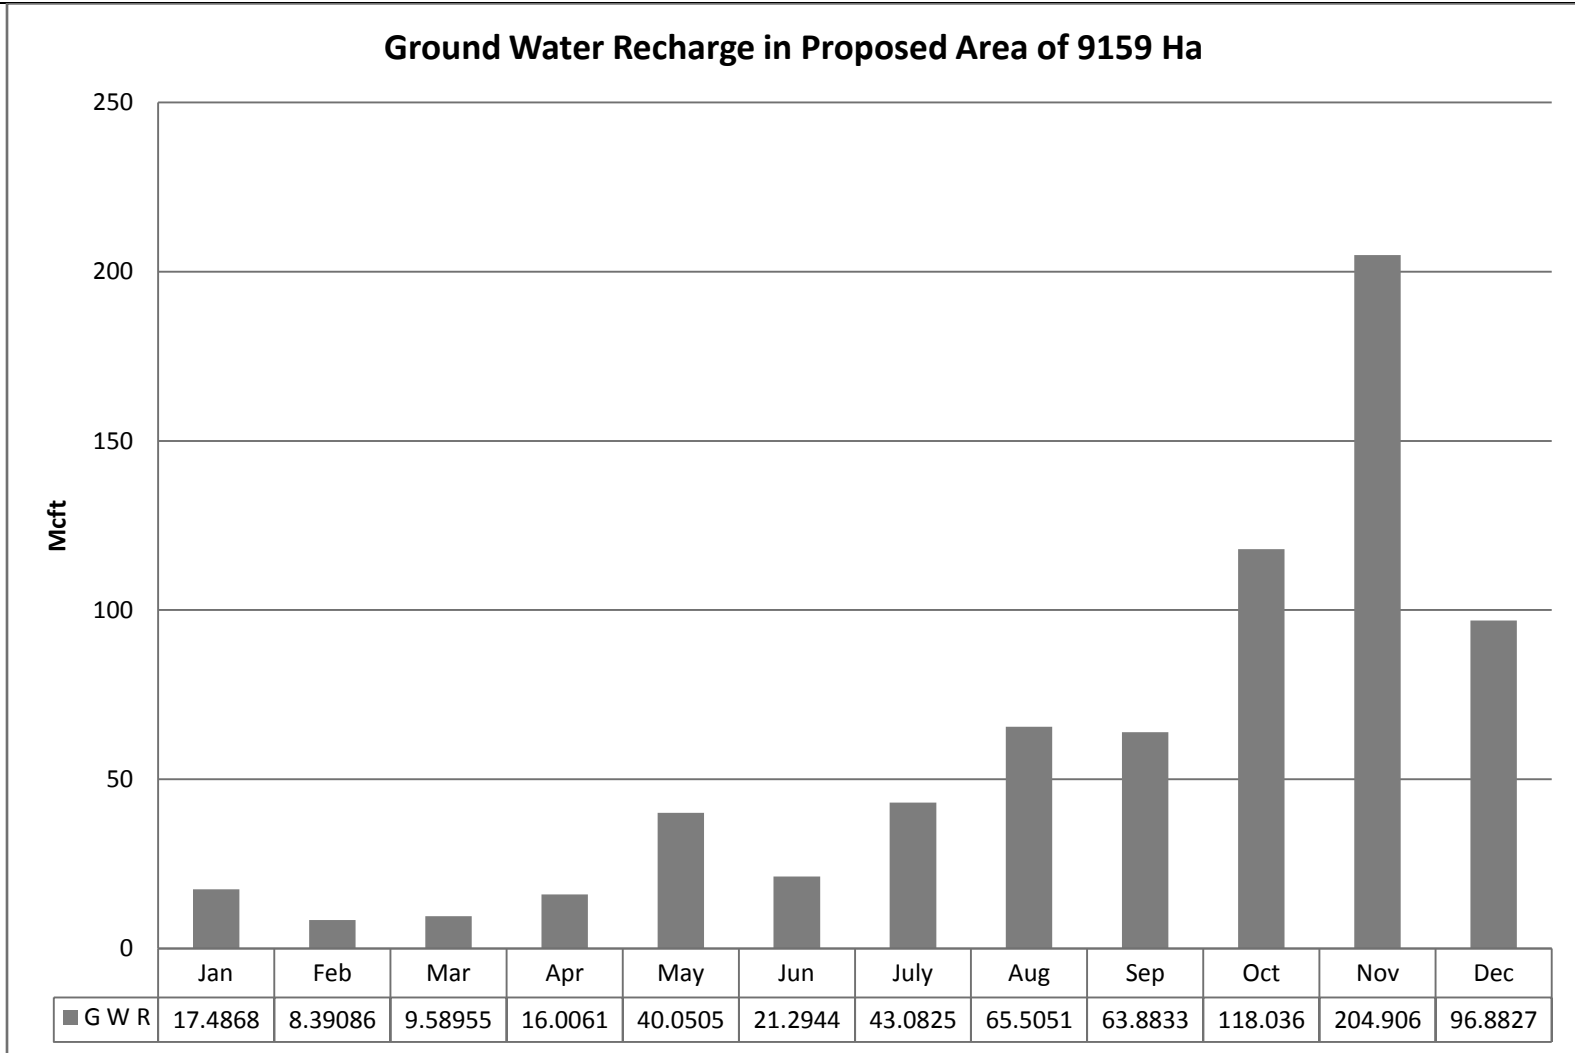
Fig No.4.11 Chart showing ground water recharge in the proposed area of 9159 Ha

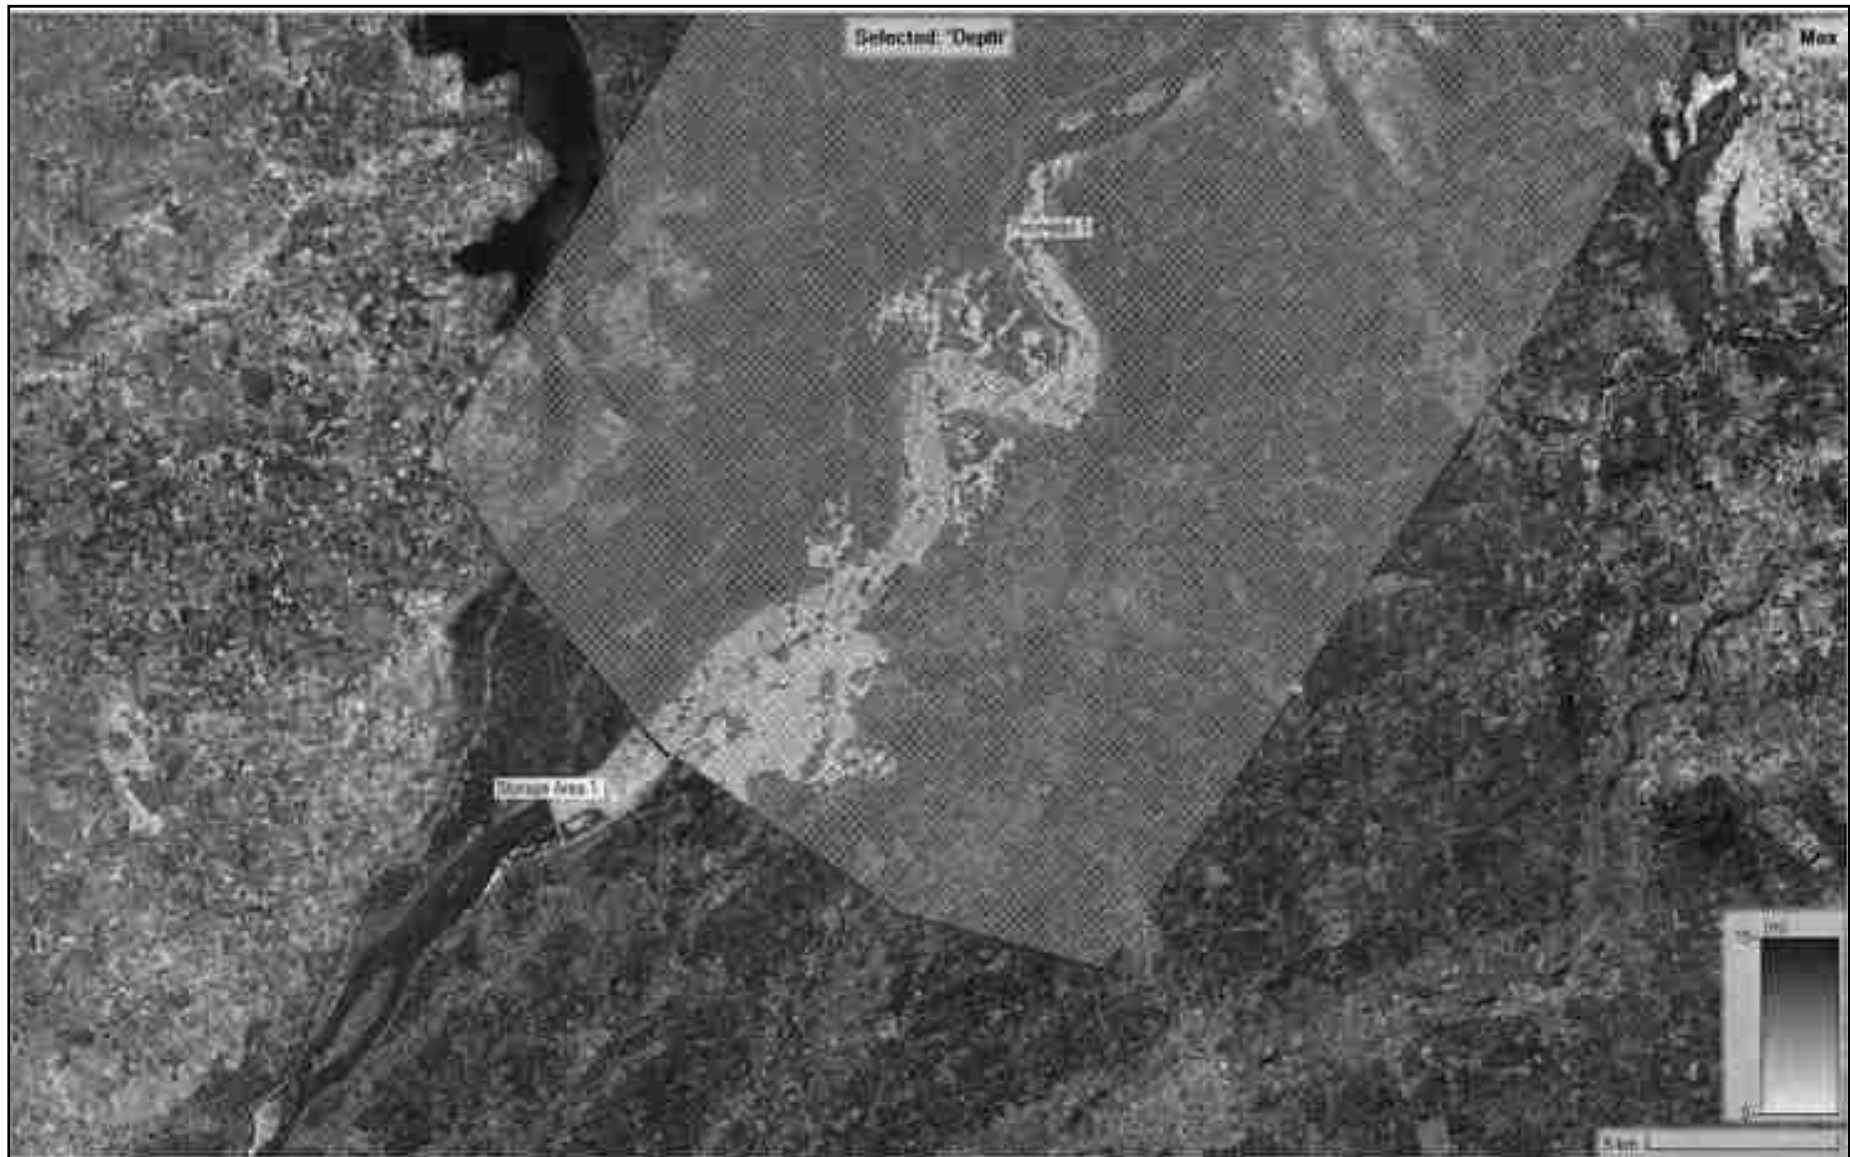
Fig Map 7.3 Image of Dam break analysis showing depth of flood water in the inundation area (Bing Satellite Map)

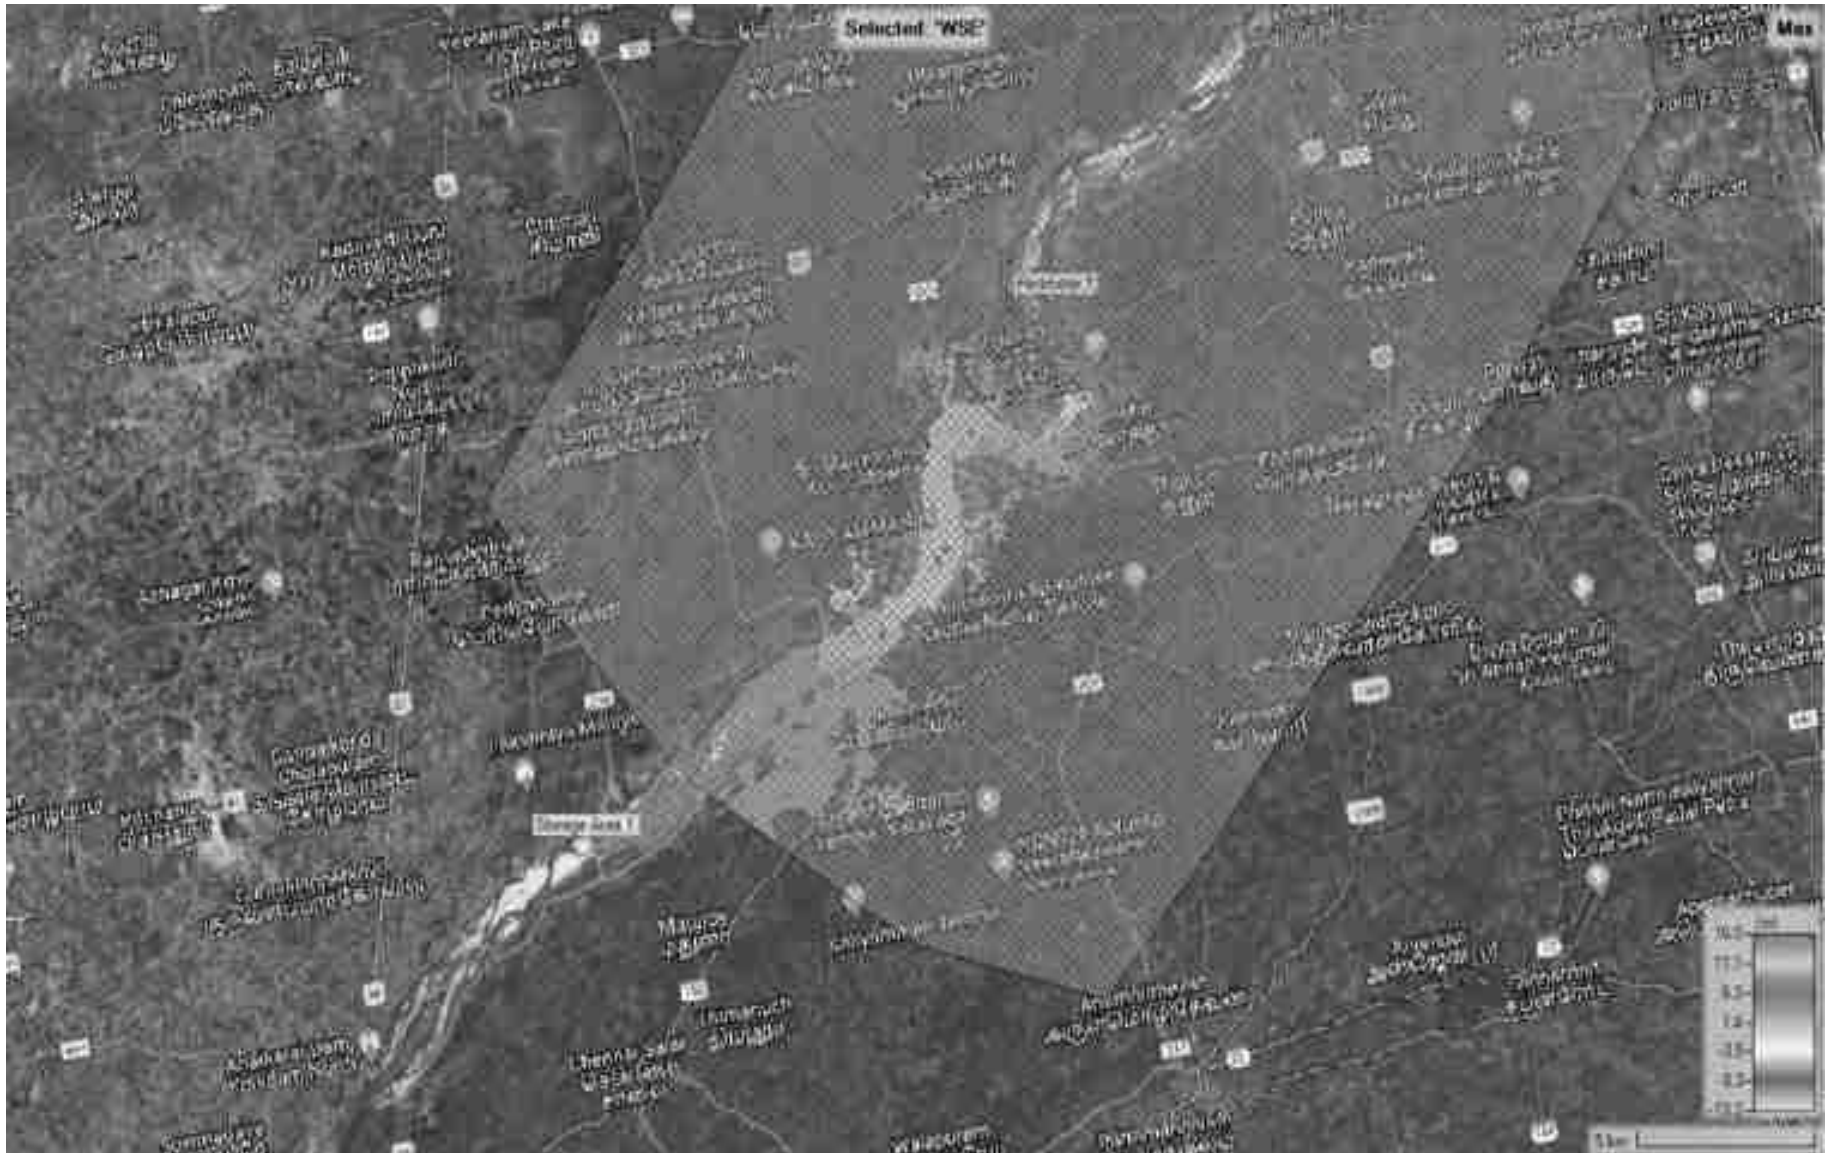
Fig Map 7.5 Image of dam break analysis showing elevation of water surface level over inundation area (Satellite Map)

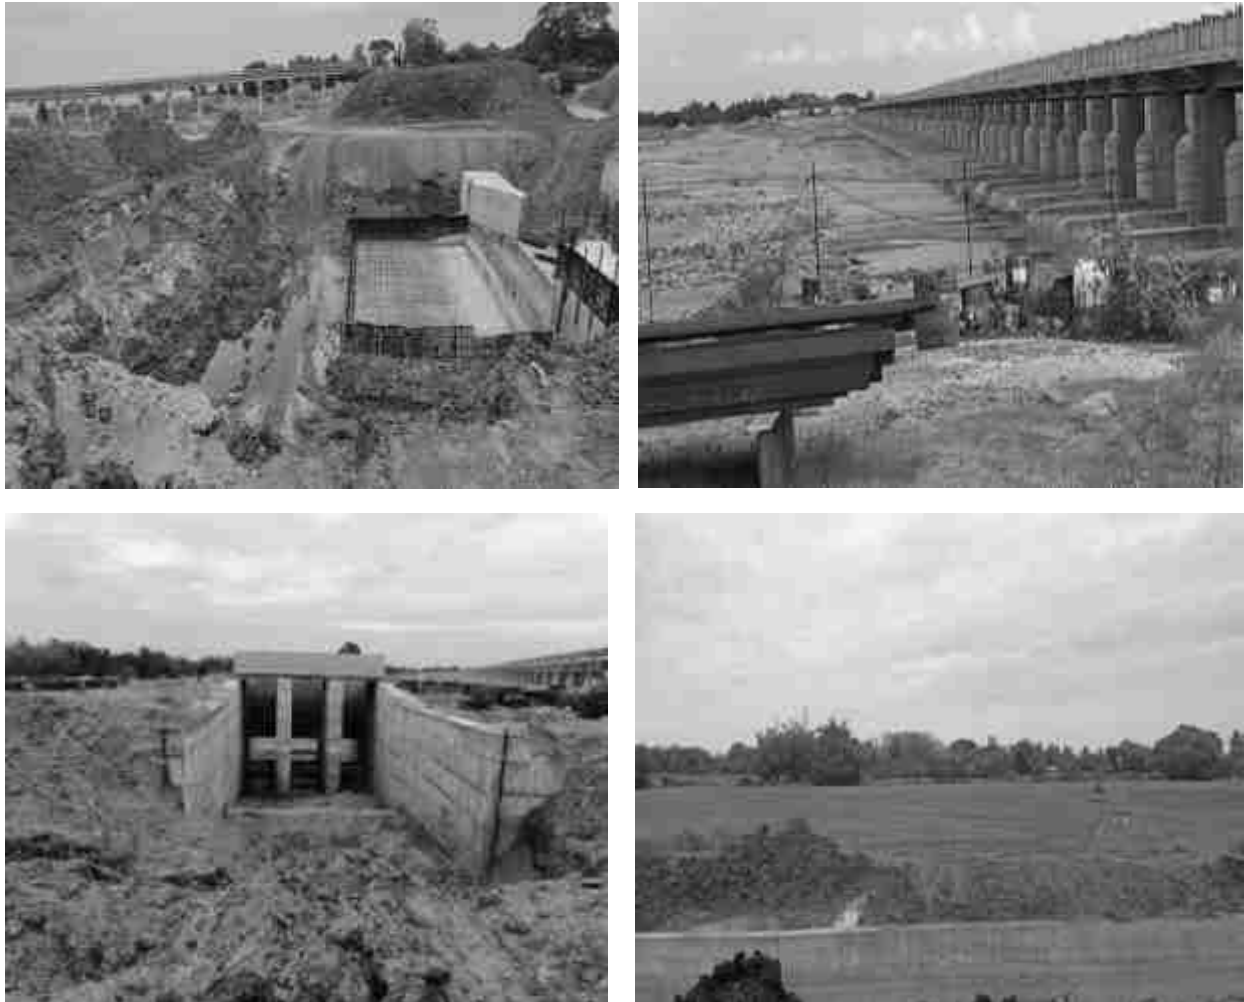
Fig 13.1 Showing improper dumping of earth and scattering of construction materials, wastes
