# **EXPERT COMMITTEE REPORT FOR ASSESSING THE DAMAGES BY FLY ASH IN THE ENNORE BACKWATERS**

**MARCH 2022**

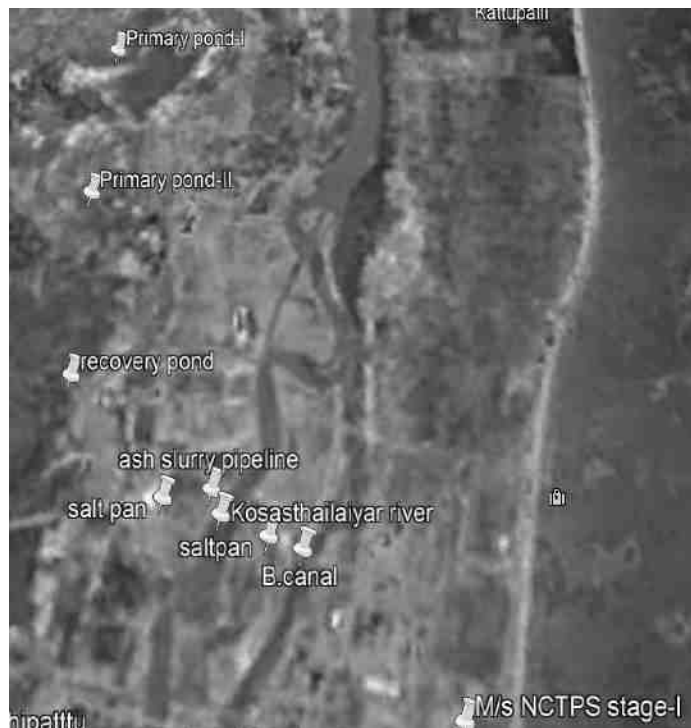
Figure-1: Google image December 2003

From figure-1, Google earth image pertains to **December 1993** before commissioning of the unit, it was observed that the ash dykes are not constructed. During December 1994, two months after commissioning of stage-I. The construction of primary pond-I is started. From the image it was observed that the width of the Buckingham canal is varying between 40m to 50m. The width of Kosathalaiyar river is varying from 100m to 150m. There is no ash deposition in dykes, salt pan and the area surrounding the power plant.

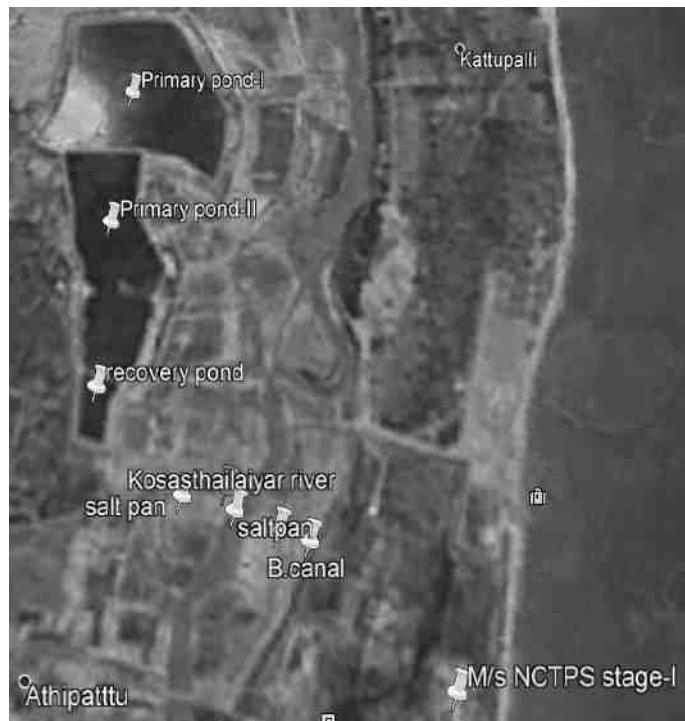
Figure-2: Google image December 1997

Initially from 1996 to 2003, M/s NCTPS disposed the ash into primary pond-I of 180 hectares. Also, it is clear from the Google image (Figure-2) pertains to **December 1997**, that part of the pond is filled with ash and remaining portion is filled with recovery water/ pond overflow. As compared to previous satellite images, the demarcation of the boundaries of the ash ponds is significantly visible. By **December 1999** around half of the primary pond-I is filled with ash and disposal

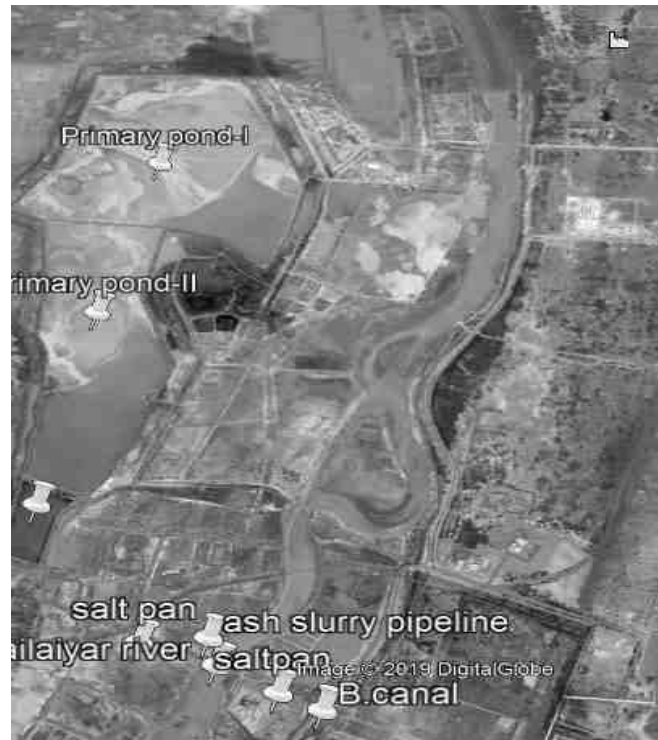
Figure-3: Google image December 2008

From Google Earth images of 2004, it was observed that in both primary pond I & II, water is overflowing into adjoining areas and also ash is deposited in Buckingham canal and salt pan. Mangroves and other vegetation is found on both sides of the canal, around ash ponds, within the premises of M/s. NCTPS and in the surrounding area of the unit. Also, it was observed that the habitation in the area is less during this period. The Google image (Figure-3) during **May 2008** shows colour change in the river indicating contamination due to over flow from ash ponds & the northern & north-eastern side of the pond

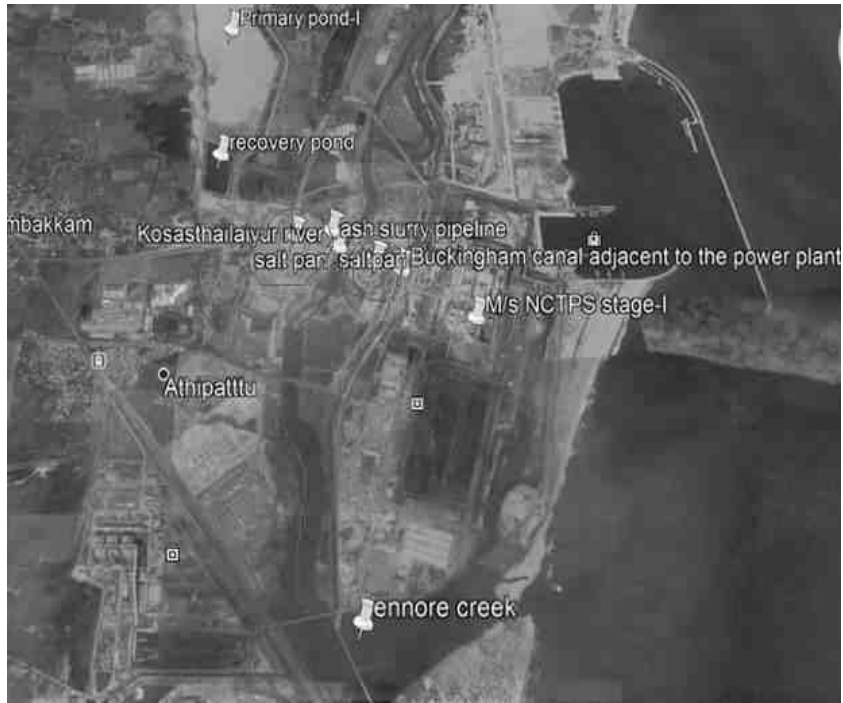
From the Google image during the period March 2018, it was observed that the ash is deposited on either side of the pipeline through most part of its length. Through the historical images it is clear that due to the activity of M/s NCTPS, ash deposition had taken place in Buckingham canal, Kosathalaiyar river and salt pan over a length of 4 KM starting from ash pond to the

creek & Red coloured lines indicate ash deposition. From the historical satellite imagery it is clear that, ash is deposited in Buckingham canal (to a length of 3 KM) in river to length of 5 KMs (2 KMs u/s of pipeline and 3 KMs d/s of

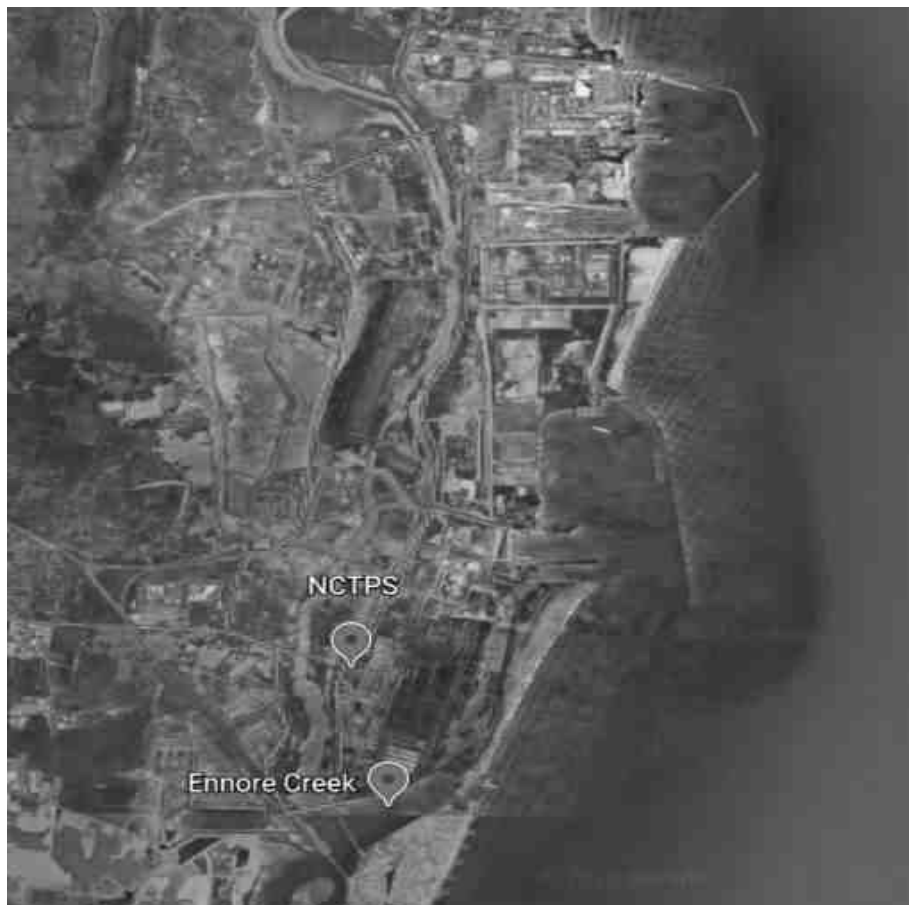
Figure 1.1.1: Study location

The study location is the Kosasthaliyar River and its riparian regions, located in the north of the Ennore creek. The study area stretches from Ennore creek in the south up until Kattupalli village in the north. The area of the study location as seen in Study locationFigure is 12.5 km<sup>2</sup>. The study area encompasses fly ash pipeline, the Kosasthaliyar River, the Buckingham canal, ash pond and the NCTPS. Various Industrial complexes lie on either side of the northern arm of the Kosasthaliyar River. The NCTPS lies on the south-east of the study location.

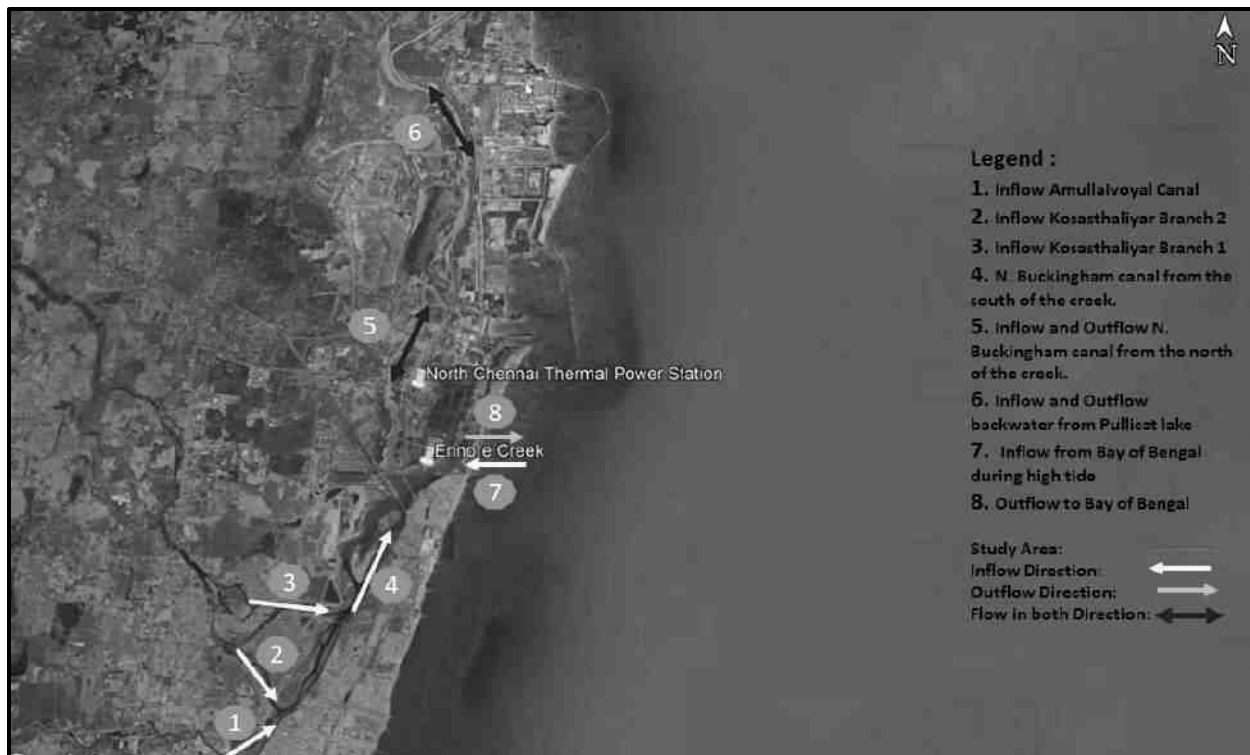
Figure 1.1.1: Inflow and Outflow into the Ennore Creek

**Outflow:** Possible discharge from the study area into the Ennore creek and to the Pulicat Lake during low tide as shown in Figure 1.1.1 <sup>(7)</sup> and runoff during monsoon season.

Most of the year, the freshwater flow from both Kosasthaliyar and Amullaivoyal are almost zero. Thus, the effective inflow and outflow of the creek is very much negligible <sup>(7)</sup>. Hence, the hydrodynamics of the study area is primarily dominated by tidal fluctuations, that play a major role in sustaining the flora and fauna of the Ennore backwaters. This delicate balance of this fragile tidal ecosystem is destroyed by the fugitive fly ash emissions from the slurry ash pipes due to non-adherence to the maintenance protocol by the NCTPS.

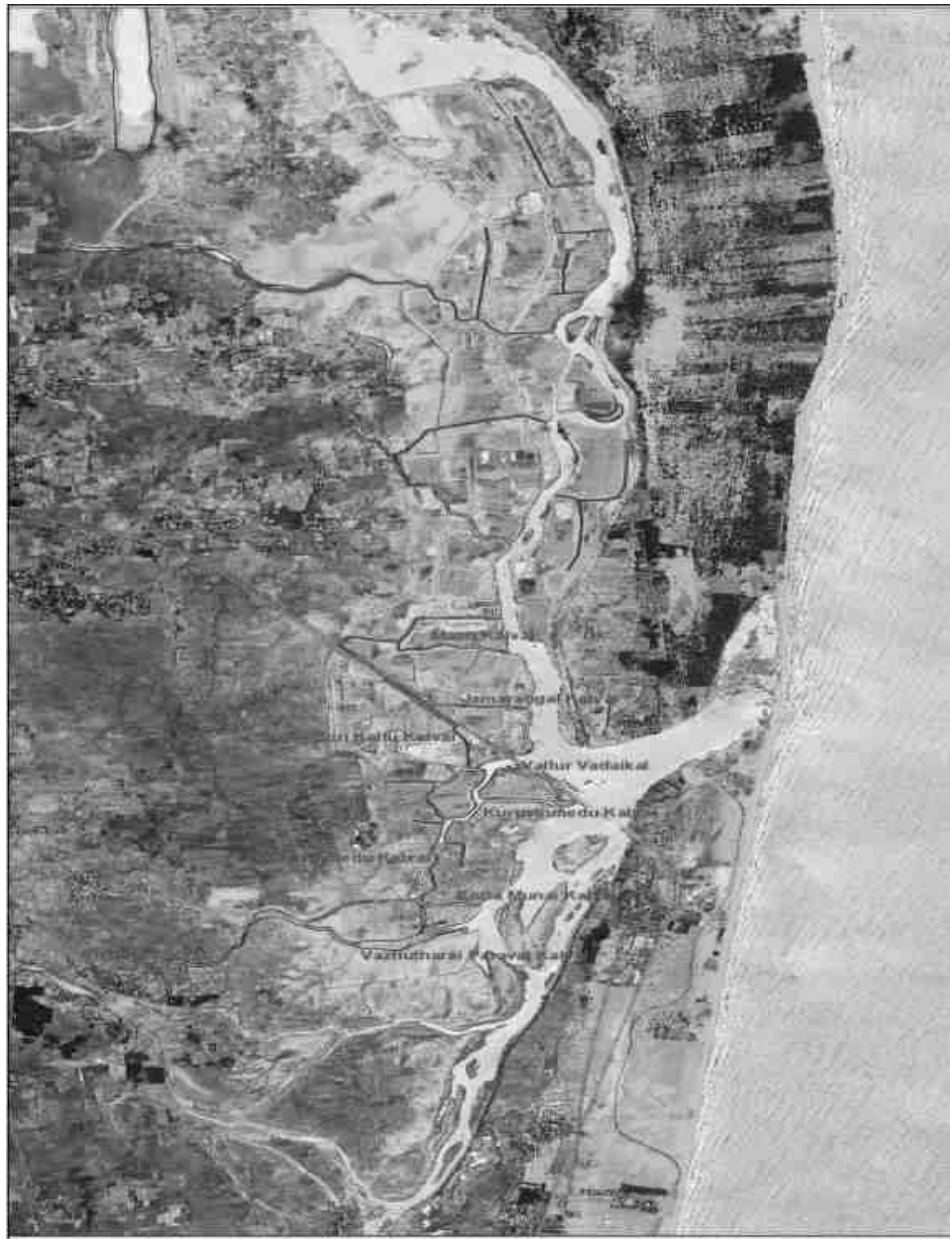
Figure 1.1.3: Natural drains/canals in the Ennore region circa 1965. [adapted from <sup>(6)</sup>]

- Fly ash is one of the effluents that continue to deteriorate the creek's water quality.
- Fly ash mixing into the river occurred mainly due to the leak in the ash pipeline and the leakage from the ash pond.
- Fly ash deposits were found in about 106 acres of creek area with an average depth of 0.5m. **Fly ash dumping in the adjacent area of the creek mounts up to 2 lac m<sup>3</sup> <sup>(6)</sup>.**
- Out of the 23 canals in the region (Figure), NTECL's 300-acre fly ash dump submerged 7 of the canals.

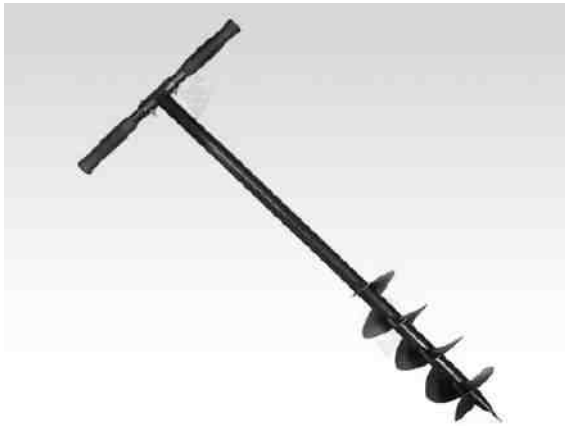
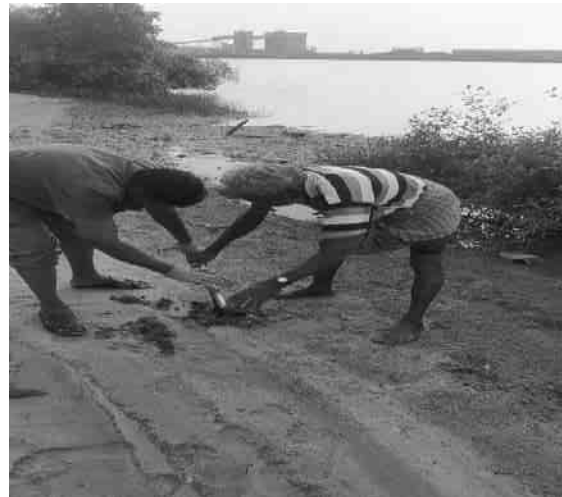
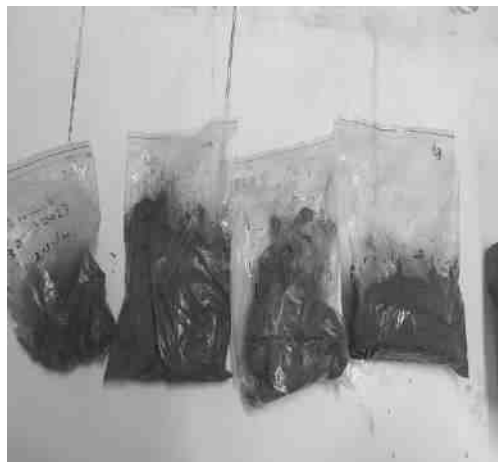
Figure 1.2.8: Fly ash sample collection at site

Hand-held screw auger technique was adopted to measure the depth of fly ash sediments present in the soil within the study area. The screw auger consists of a helical screw blade at the bottom end, which can penetrate deep into the ground as the handle at the top is rotated. The sediment samples were collected at every 100 m using the helical screw which was then carefully transferred into plastic zip lock covers as shown in Figure 1.2.8 and Figure 1.2.9. Details of each sample such as depth, appearance, location (latitude, longitude), time of sample collection etc. were noted down for further assessment and laboratory analysis.

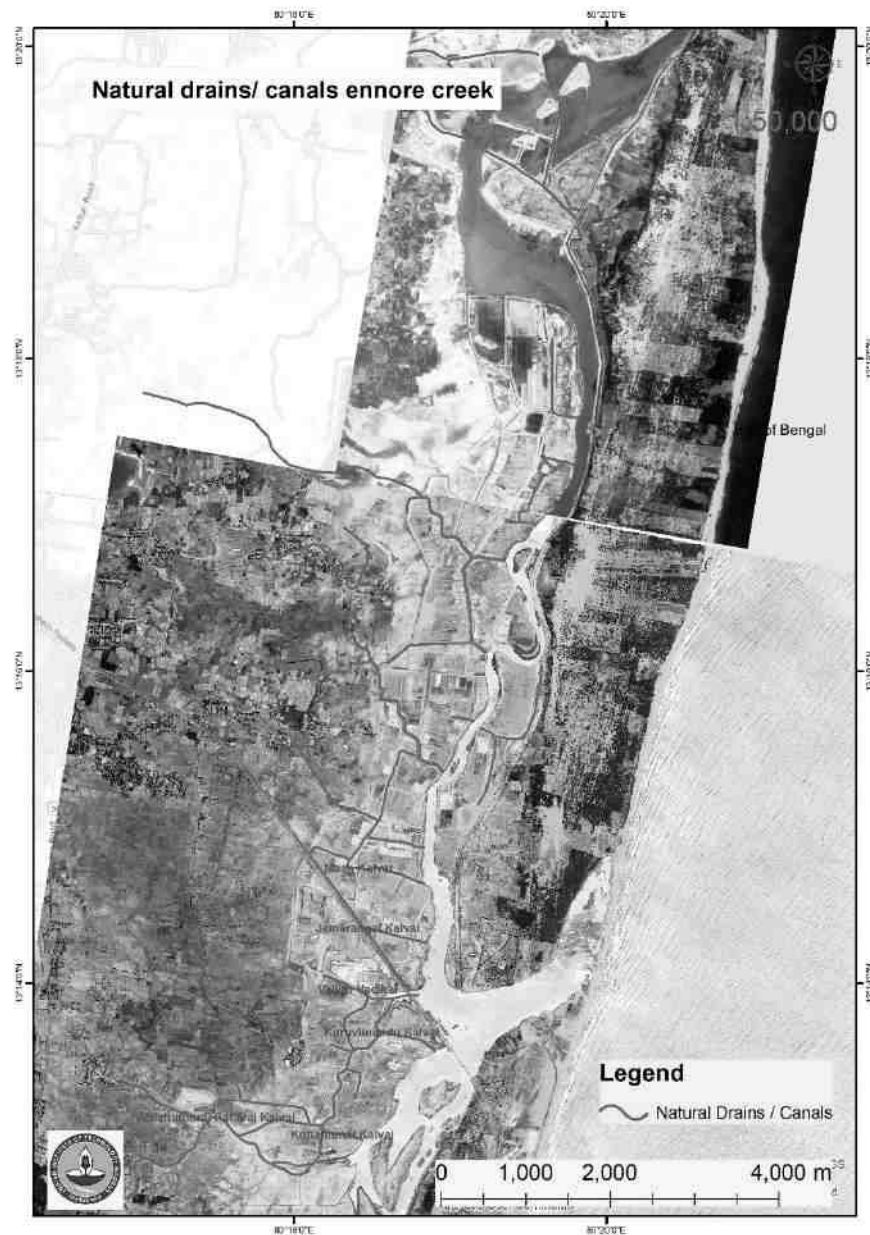
Figure 1.2.20: Drainage system of study area

The drainage system of the region is defined by precipitation falling on the land surface forming stream channels that drain towards a catchment outlet (lowest point). The drainage system plays a crucial role in ensuring effective disposal of excess rainfall. So,

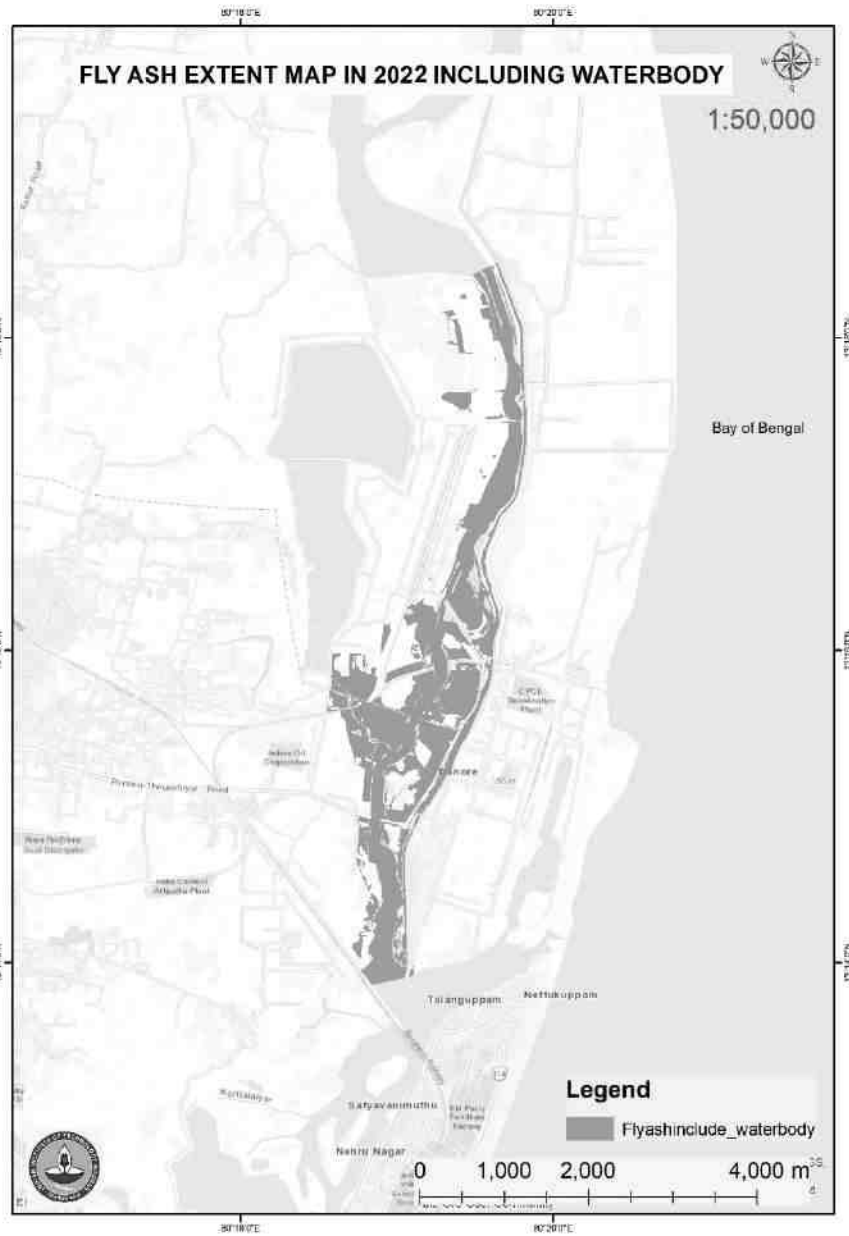
Figure 1.3.9: Fly ash extent in the study area

To overcome the depth limitations of hand auger and to collect deeper core samples, M/s Stratus conducted auger bore sediment sampling in 32 locations in the study area and determined that the maximum depth of fly ash deposition was up to 2.74m.

The Fly ash thickness in the study area extent was calculated by interpolating the sediment sample location and their corresponding depth information using the nearest neighbor method (Figure 1.3.10).

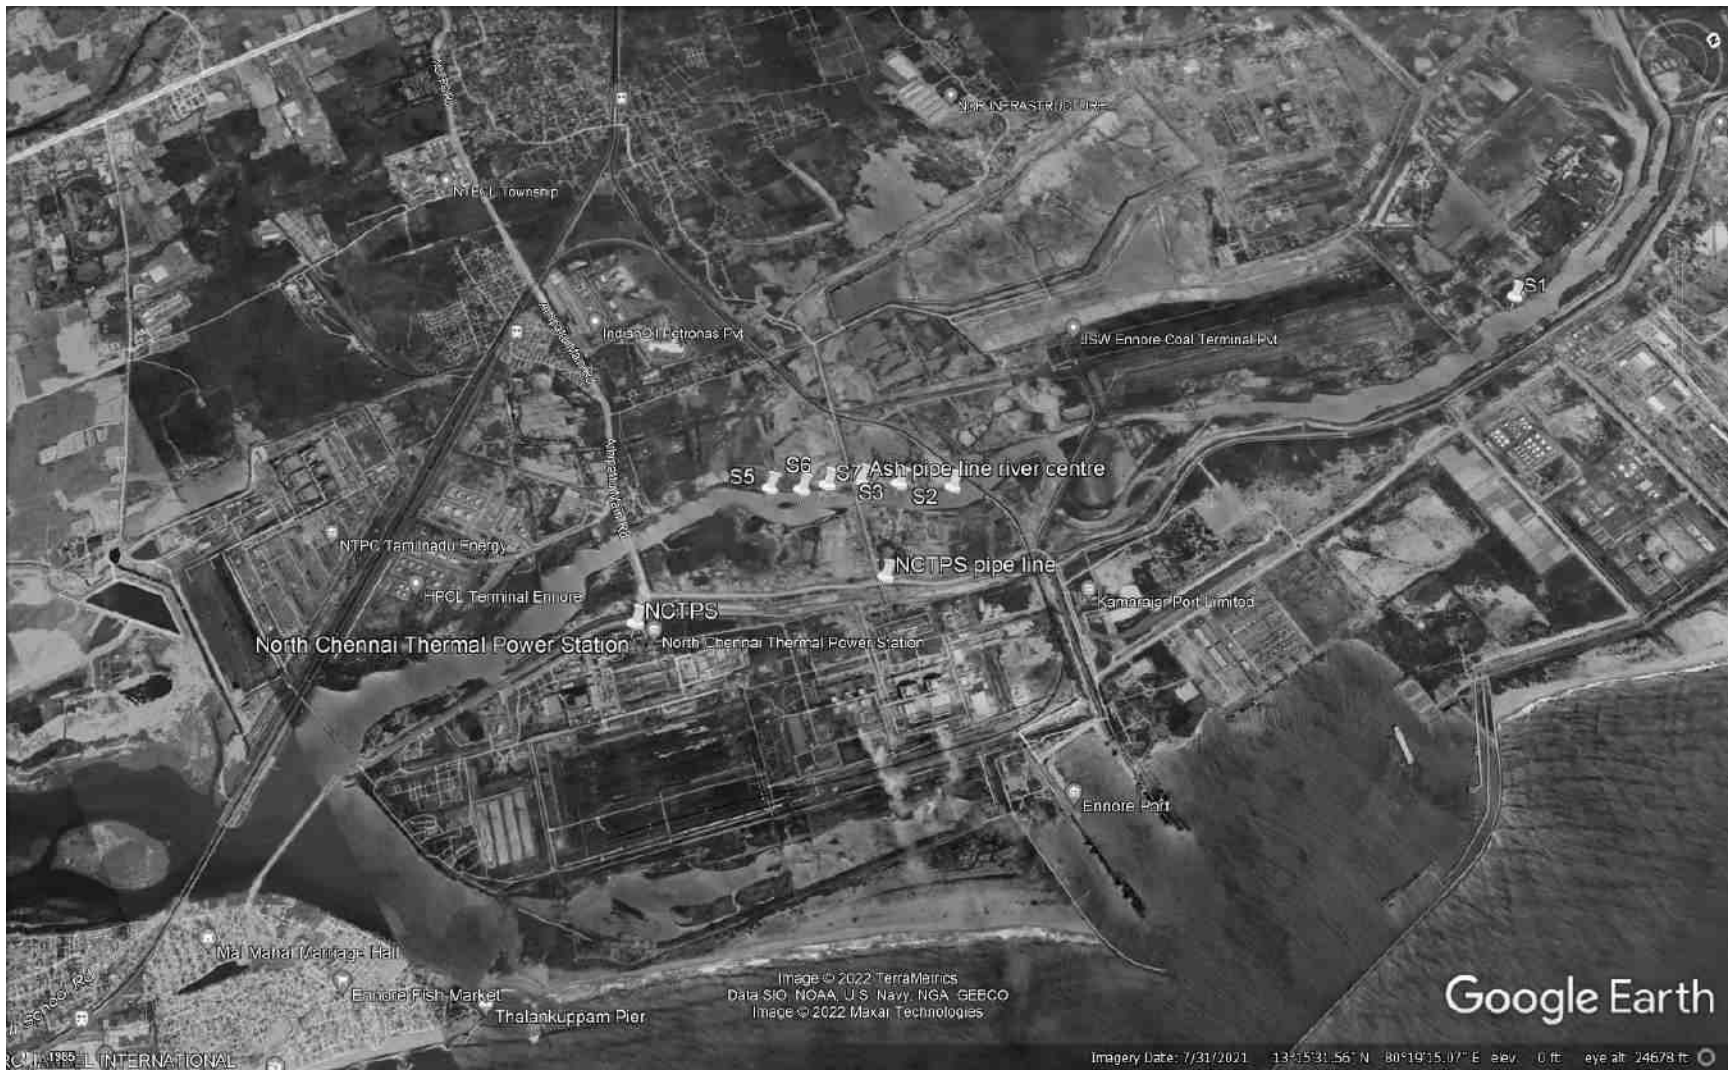
Figure 14 Grab sampling locations in the study area in Kosasthaliyar river

There is not much variation in the concentrations at different points along the river. Two hotspots were observed 500 m upstream and 500 m downstream where the concentrations were significantly higher than the other locations

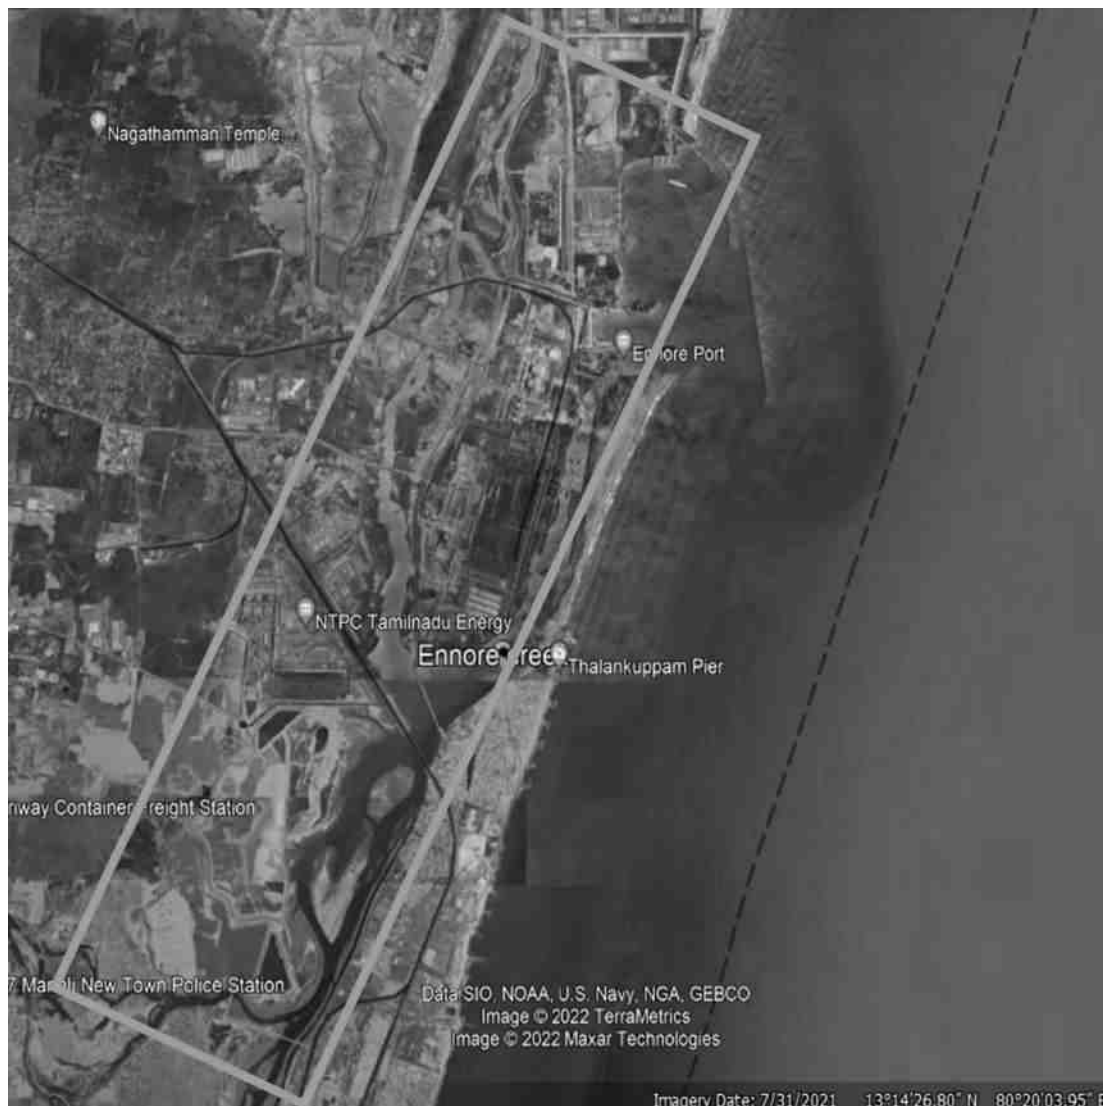
**Figure 1:** The location of Ennore Estuary within the area of interest

The Ennore estuary (13°13'54.48"N, 80°19'26.60"E) lies on the northern part of Chennai and is connected to the Pulicat Lake in the north through Buckingham Canal and Kosasthalaiyar River in the northwest. The dynamic shore currents constantly accumulate sand near the bar mouth of the estuary classifying it as "*bar-built estuary*". Bar-built estuaries are characterized by barrier beaches that form parallel to the coastline and separate the estuary from the ocean. Dredging is undertaken periodically in the mouth area to assist mixing of seawater and to connect the estuary as a navigational channel for the local fishermen. Prior to dredging, the sand bar at the mouth remained closed for at least six months of the year and was only connected to the sea during the north-east monsoon (October-December).

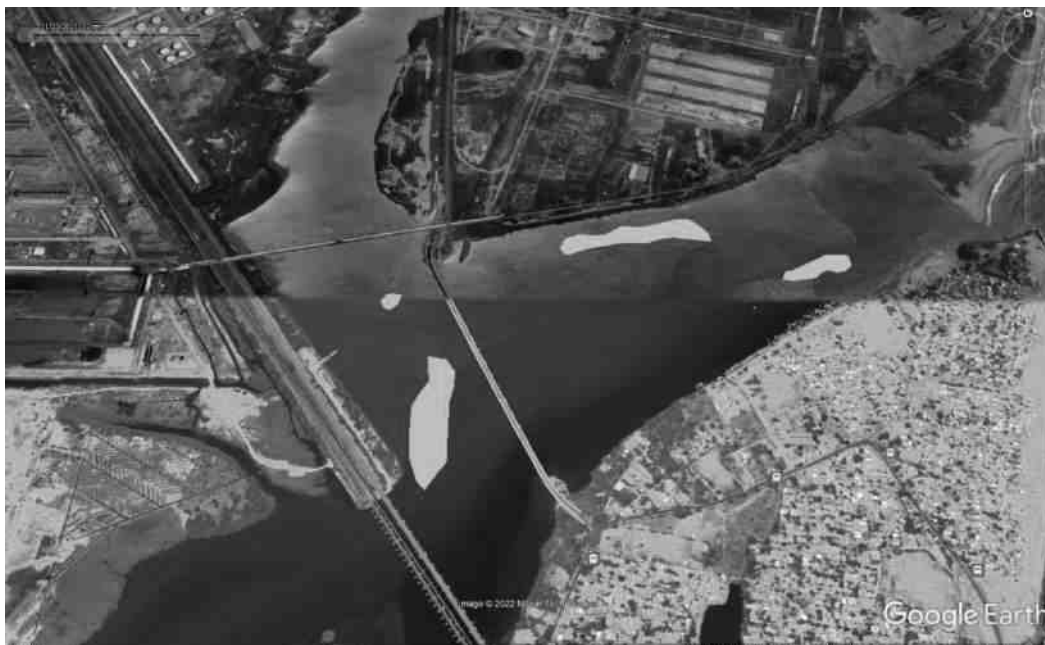
**Figure 5: Current location of live edible oyster beds in the Ennore creek area**

Oysters develop successfully because of good substrata available in the creek. Dead oyster shells act as good spat settlement substrata for spat settlement and establishment of oyster beds. It is also significant to note that once the estuary had numerous oyster and mussel beds that have been drastically lost in the recent years due to various anthropogenic impacts and degrading water quality. Fishermen term the oyster beds as **“ASTHIVARAM”** meaning foundation to the Ennore estuary because of the ecosystem services provided by them such as fishery and filtering of excess nutrients. Because of the fall in fish capture in the creek, one fisherman indicated that they are now tampering with the Asthivaram. The current location of the oyster beds is provided in the Figures 5 and 6.

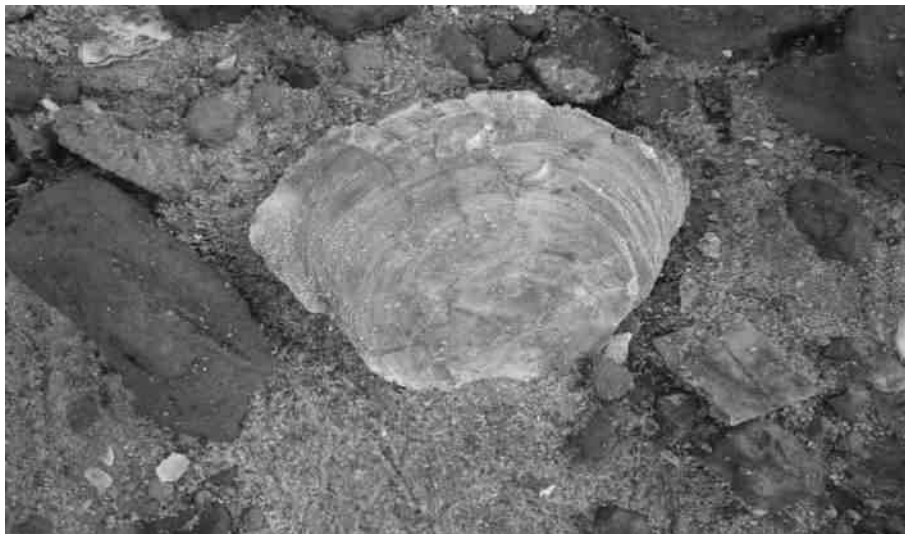
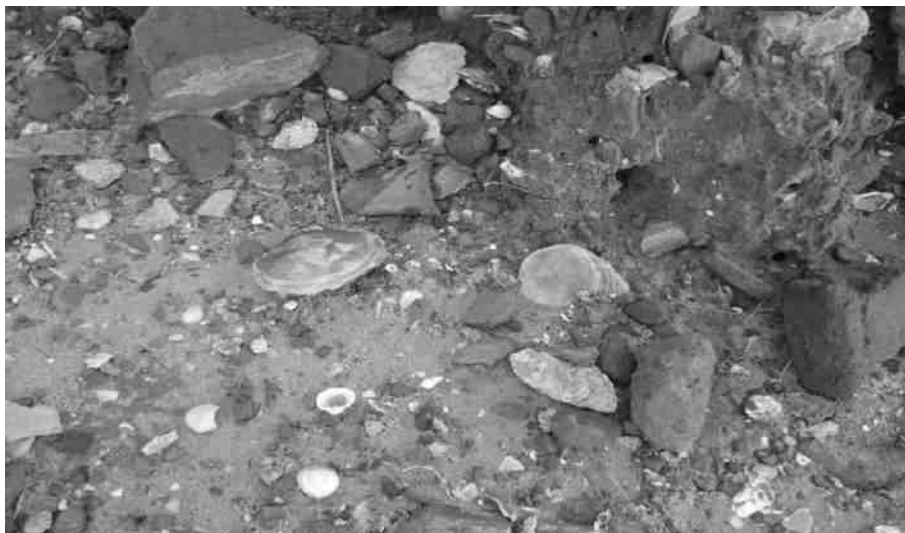
**Figure 7: The Window pane oyster – *Placuna placenta* (top) and Window pane oysters along with dredged material (bottom)**

One species of window pane oyster – *Placuna placenta* is protected under the Schedule IV of the Wildlife Protection Act (1972). This is a common species found in the estuary and is being harvested for both ornamental trade and shell lime industry. Large numbers of dead shells are observed on the banks of the estuary or with the dredged material in the Buckingham canal. Despite the fact that the water in the Ennore estuary is heavily contaminated, the window pane oyster species, along with other edible oyster species have shown resilience to the harsh polluted environment.

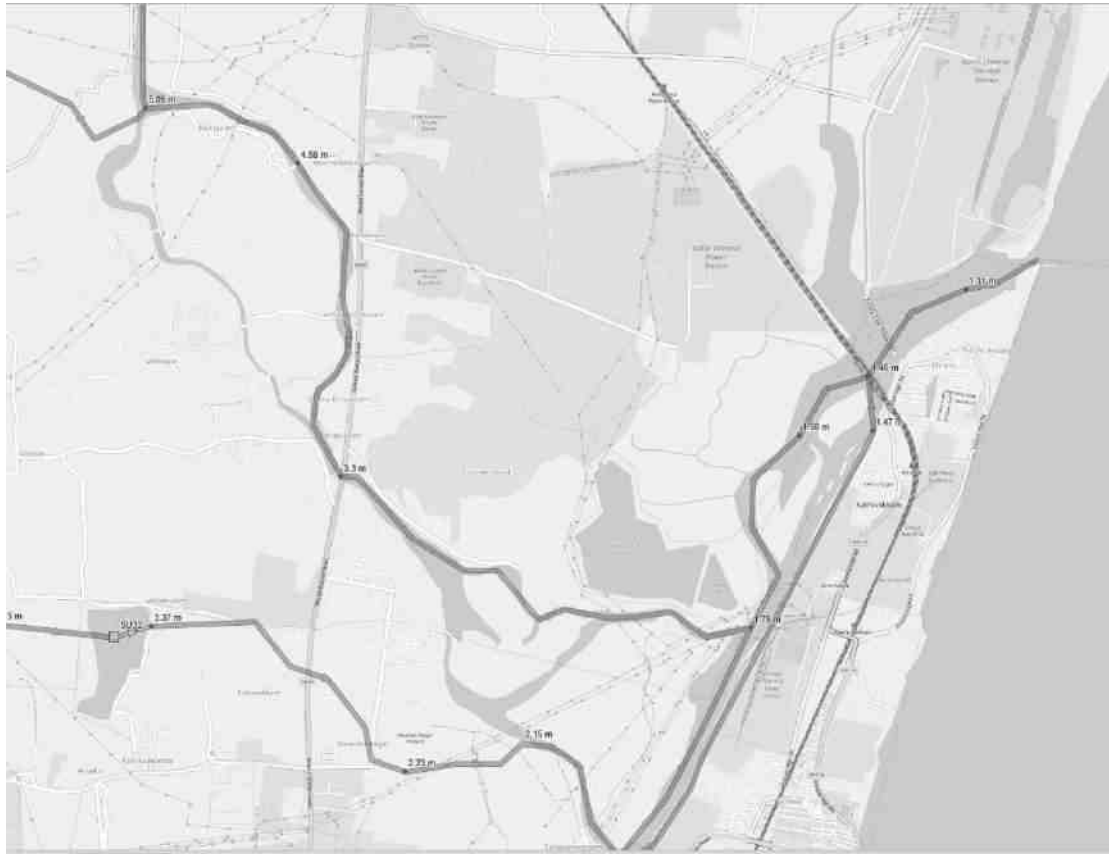
Figure 6: Flood risk area on the coast

As stated earlier, flooding of the landscape especially of the designated industrial zone on the lower part of the river is a major risk. The following map shows areas vulnerable to flooding from combined high sea level (+1.5) and river flow.

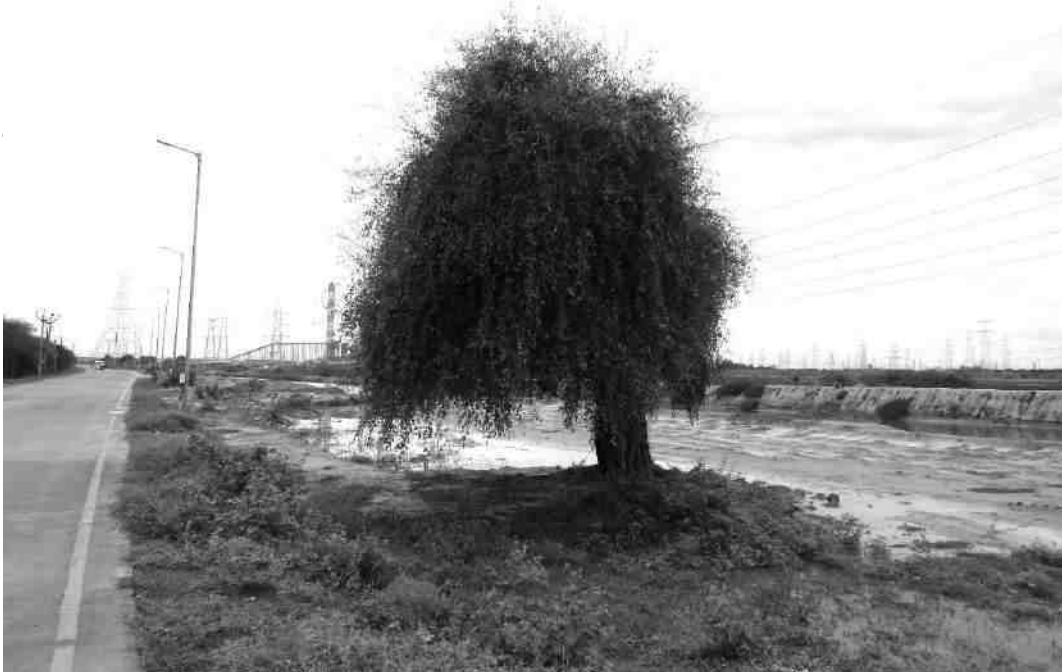
Figure 7: The tree (*Salvadora persica*) is a very old sacred tree standing near the entrance of NCTP Field surveys

The reasons for increased Species Richness are mainly the post monsoon season followed by vast perambulation of the large area that includes a variety of habitats. The lone tree *Salvadora persica* (*Ugha* in Tamil) found near the entrance gate of NCTP and along the service road is of conservation significance. The tree should be at least 200 years old and should be preserved for not only its sacredness along the Coromandel coast, but also for its habitat specificity and ethnomedicinal value. There are two more saplings of this tree in the ash affected area near the Prosopis Dominant region

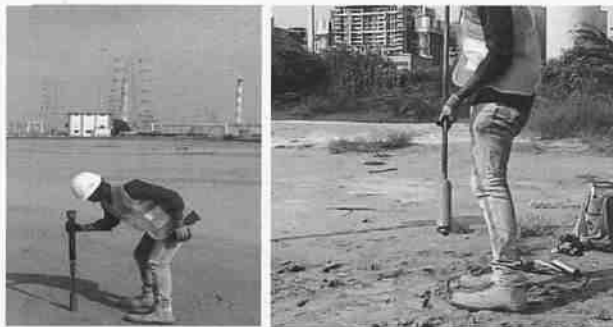
Figure 4. Undisturbed core samples collected using slide hammer auger (18 locations)

The in-situ dry bulk density of the core samples at different depths and sites ranged from 0.990 g/cc to 1.801 g/cc thus indicating different levels of compaction of fly ash in the field. The average bulk density of different samples is about 1.341 g/cc. Hence, 8.19 Million ton of fly ash would be in volume terms vary based on the level of looseness or consolidation in the field.

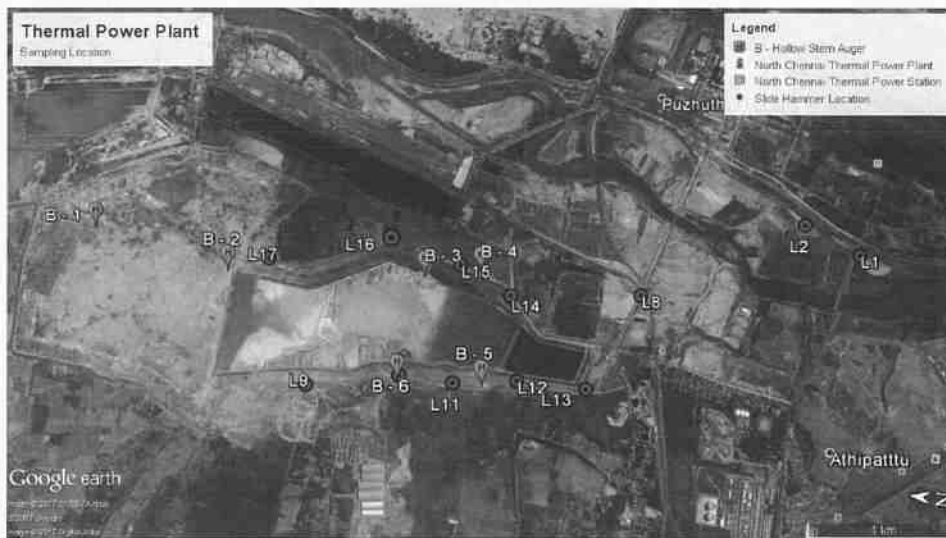
Figure 6. Undisturbed fly ash core sample collection locations

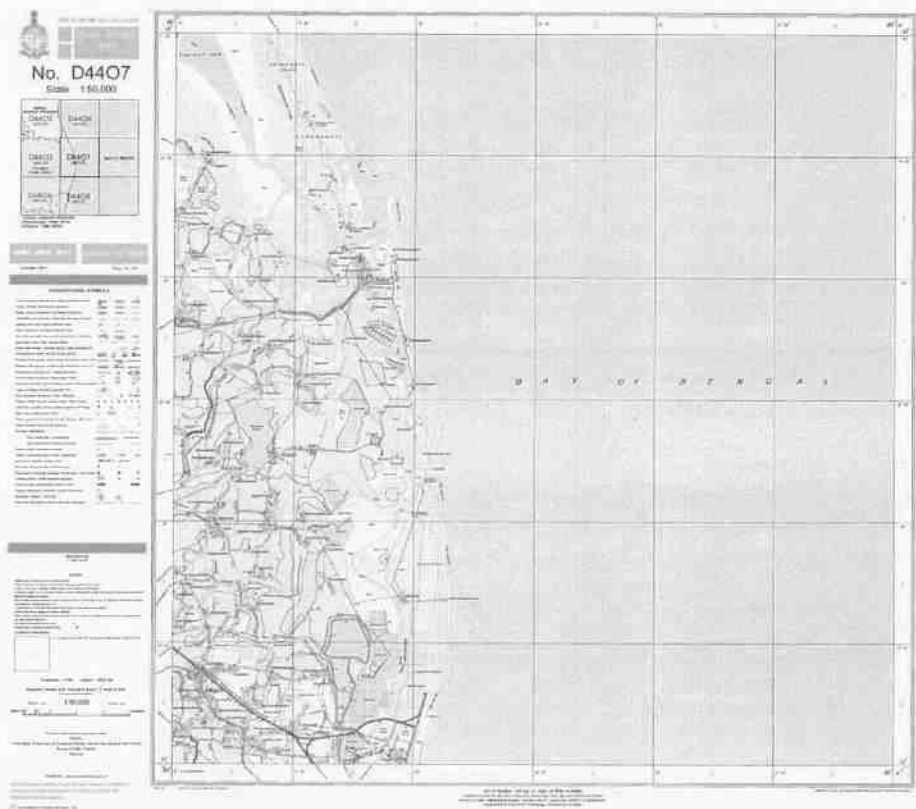
Figure 7. Survey of India toposheet clearly showing the affected area as salt pan region

The survey data of the region from the recent survey of India open series map clearly shows the fly ash affected region to be predominantly salt pans. (Figure 7). This corroborate well with the 1965 declassified aerial imagery (Figure 8) from NASA which clearly shows the predominant salt pan activity in this region. Further this image also clearly shows the free cross drainage of runoff through the salt pan region into the Kosathaliyar river.

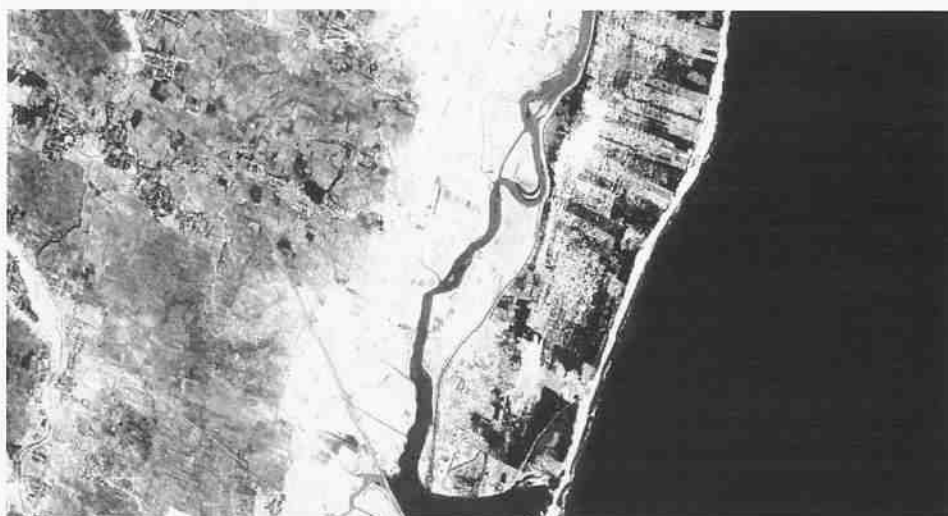
Figure 8. High resolution aerial imagery of the region acquired from the declassified imagery of NASA acquired during the 1960's (most probably 1965)

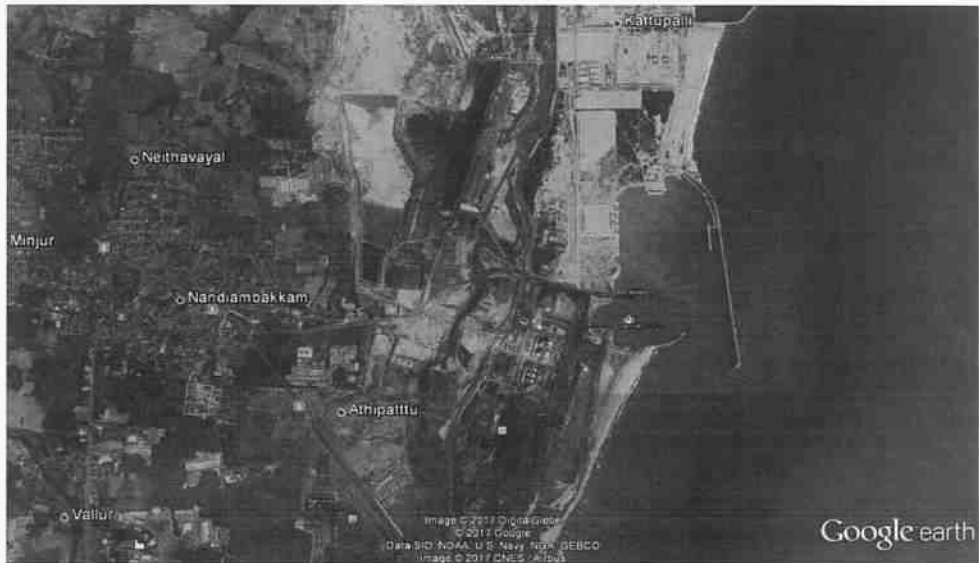
Figure 9. High resolution satellite imagery of the region from google earth (between February and March 2017)

The recent google earth imagery as well as the field visits clearly shows the extent of fly ash spill in the region and the devastation it is causing to the sensitive marshland ecosystem.
