TAMIL NADU POLLUTION CONTROL BOARD

Report on the inspection carried out by the Technical team to ascertain the cause of the recent oil leak in the Ennore Creek Area as per G.O.(Ms) No.178 Environment, Climate Change and Forests (EC3) Department dated 10.12.2023:

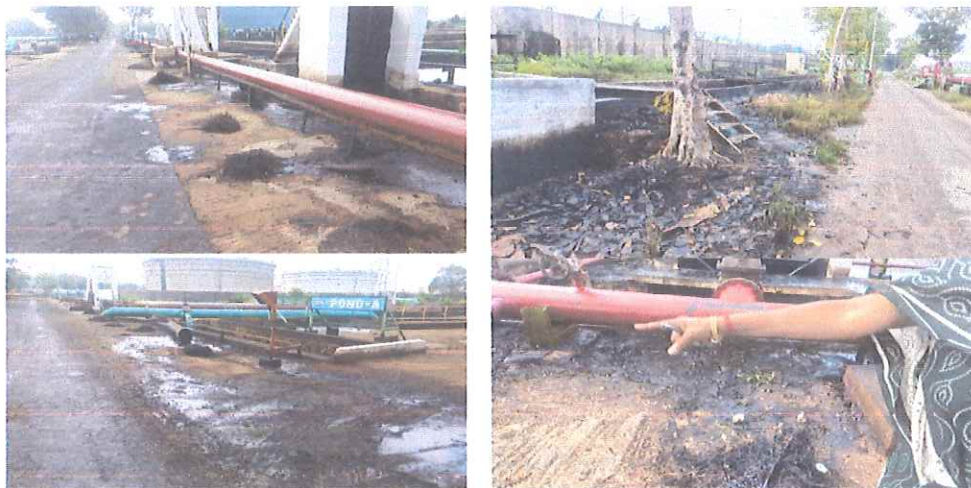
1. The storm water collection pond A was inspected and it was observed that there is a provision to pump the storm water to collection Pond C and there is an outlet leading to Buckingham canal. Under normal circumstances, the Pond A storage water is pumped into ETP, however, it is pumped outside the premises into Buckingham canal during heavy rains. Though, there is an oil water separator provided, as the level of storm water raises above the pond level, there seems to be an over flow which can reach the Buckingham canal along with huge quantity of floating oil.

2. This could be found evident from the traces of oil on the shrubs, roads, side walls located in and around the Pond A area. There is a surge pond located adjacent to Pond "A" where lot of oil spillages were noticed and cleaning operation was under progress. Though this pond is reported to be not in use, the stagnated water in this pond with high oil content could have been overflowed into Buckingham canal from M/s CPCL premises.

Oil spill observed around Storm water collection Pond A

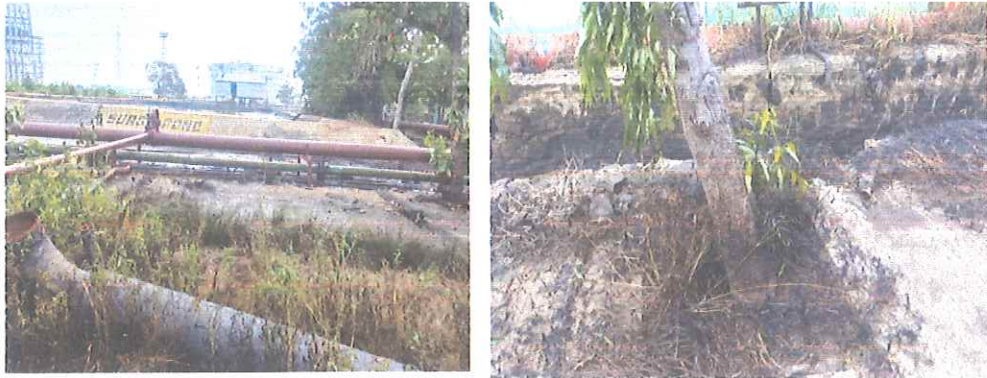
Surge pond and drain opposite to surge pond

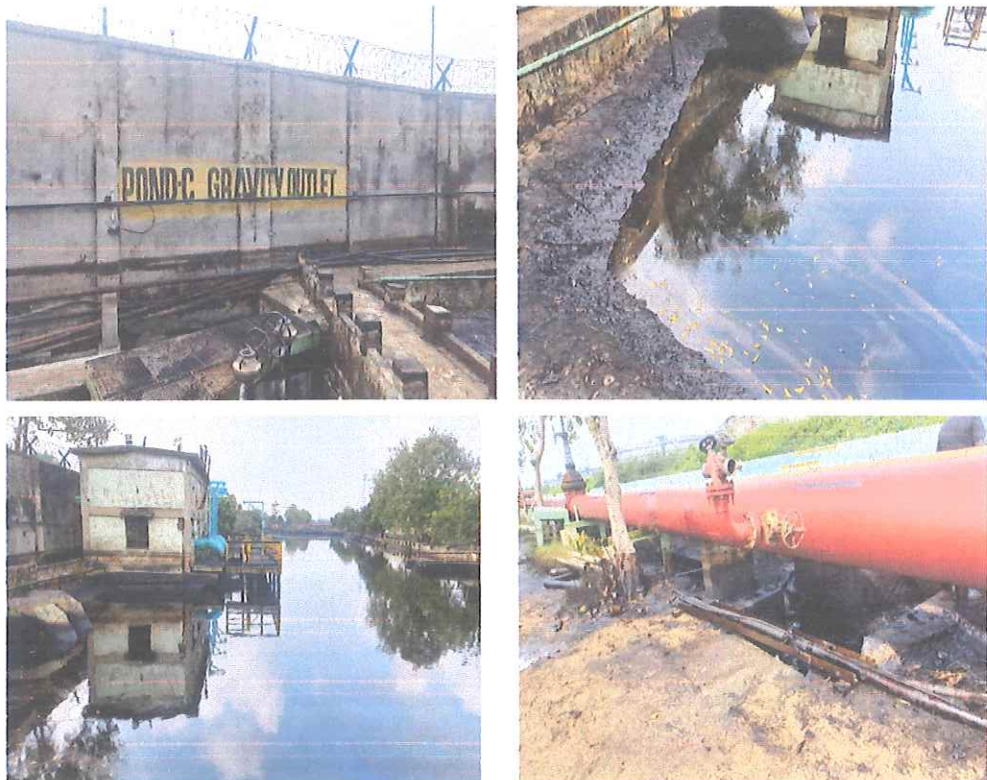
3. During inspection of the Pond "C", it was noticed that there is a provision to pump out the water for further treatment in the ETP for reuse. However, there is also a provision, where the water stored in the pond shall directly reach the Buckingham Canal. There are also possibilities that oil may be directly flowing out when the level of water is raised more than the brim level of the pond.

Oil slick observed near Pond C and its surroundings

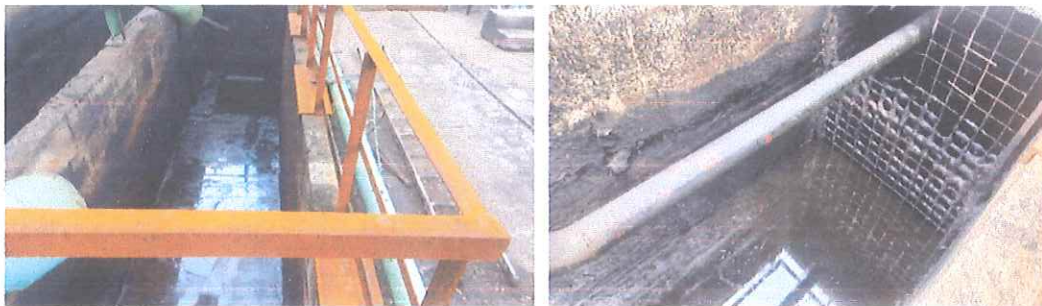
4. In Pond "D" also, there is a provision to pump out the storm water for further treatment in ETP for reuse. Here also there are possibilities of oil mixed water may be directly flowing out from the premises when the level of water is raised more than level of the pond.
5. In the ETP and MTF (Mandatory Tank Farm) areas, where Pond "E" is located which has also got pumping facility to discharge into the Buckingham Canal. Thick layer of oil found in the drainage area and pipe lines reveal that huge quantity of oil could have found its way to the Buckingham canal.

Drain leading to Buckingham Canal which was cleaned before inspection by CPCL

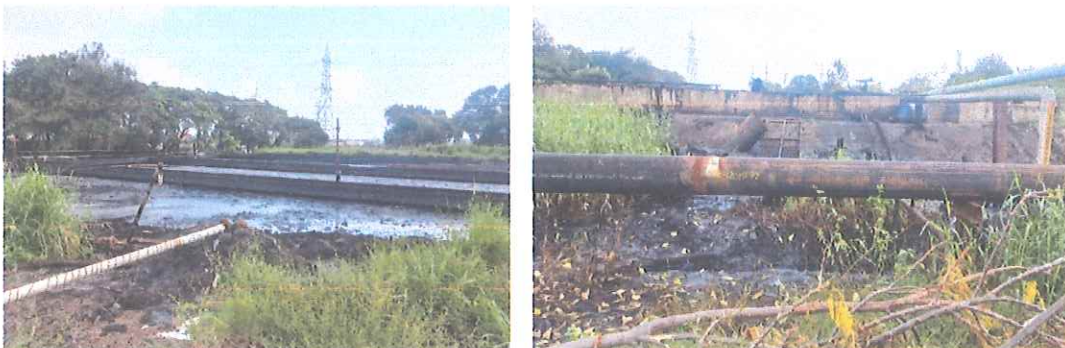
6. There is a sludge storage tank where the tank bottom sludge are brought and stored. From this sludge, oil is removed through centrifugal system for further reuse and the remaining sludge is sent for bioremediation. During inspection, it was found that there occurred an overflow which could have carried oil along with thick oil sludge to the Buckingham canal. Though this tank is situated in higher elevation, there is no proper protection to contain the overflow from during rainy days; overflow from this tank is joining the storm water drain which leads eventually to Buckingham Canal.

Oil Sludge storage tanks and its surrounding area

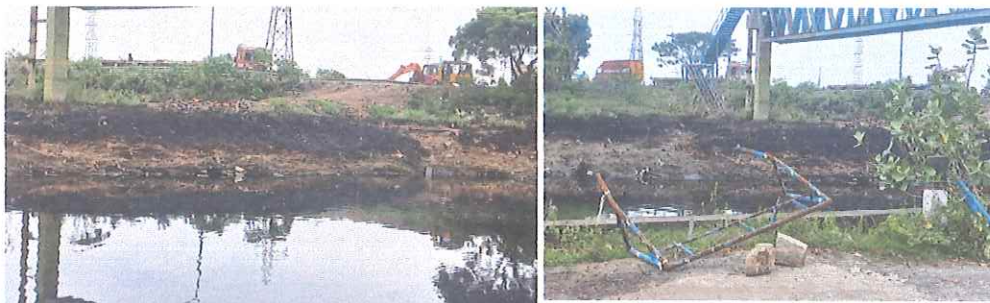
7. The bio remediation of oil sludge operation is also carried out in an open area without any roof which might have also added further discharge of oil content into the Buckingham canal.
8. During inspection of Buckingham canal, there were no traces of oil found in the upstream side of M/s CPCL, whereas oil deposits are found continuously in the banks of Buckingham canal in the downstream of M/s CPCL storm water outlet points. There was flow in the Buckingham canal which was also carrying oil traces in the downstream of M/s CPCL discharge points.

Oil Slick observed on side walls of Buckingham canal

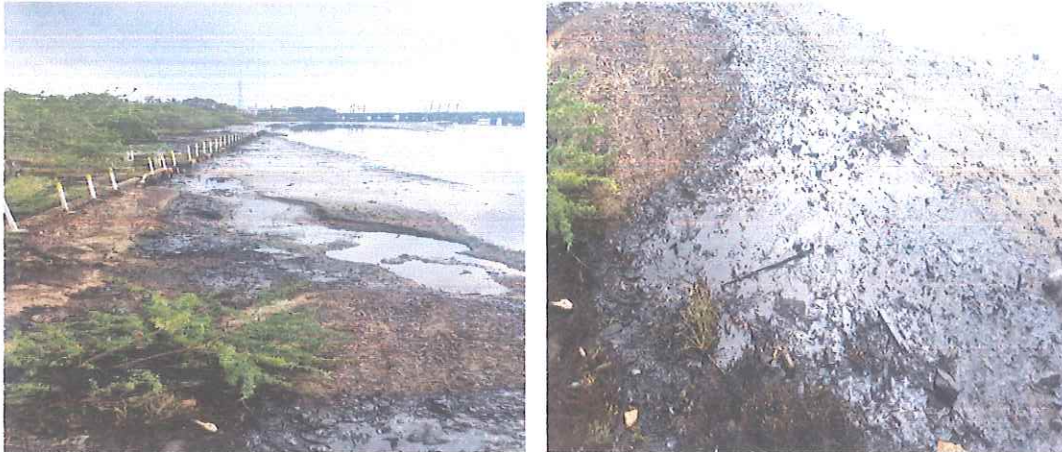
From the above observations, the committee has come to a conclusion, that because of the huge quantity of oil used and the inadequate storm water management and storm water storage ponds, it is evident that oil has leaked from M/s. Chennai Petroleum Corporation Ltd. into the Buckingham canal which has reached the Ennore Creek.

Oil slick deposited in Ennore creek

The cleanup operation carried out by M/s CPCL in the Ennore creek was also inspected by the committee and found that the magnitude of the cleaning is very low when compared to the level of cleaning operations to be undertaken for the removal of oil in the Buckingham canal and Ennore creek.
