**BEFORE THE HON'BLE NATIONAL GREEN TRIBUNAL,  
Principal Bench, New Delhi  
In  
Original Application No. 108/2020**

**News item published in the "Indian Express" dated 01.07.2020 titled "Tamil Nadu Neyveli boiler blast: 6 dead, 17 injured".**

**The Independent Report on  
“Tamilnadu, Neyveli boiler blast; 6 dead, 17 injured”  
in compliance with the Order of  
Hon’ble NATIONAL GREEN TRIBUNAL,  
Principal Bench, New Delhi  
in The Matter of OA No: 108/2020**

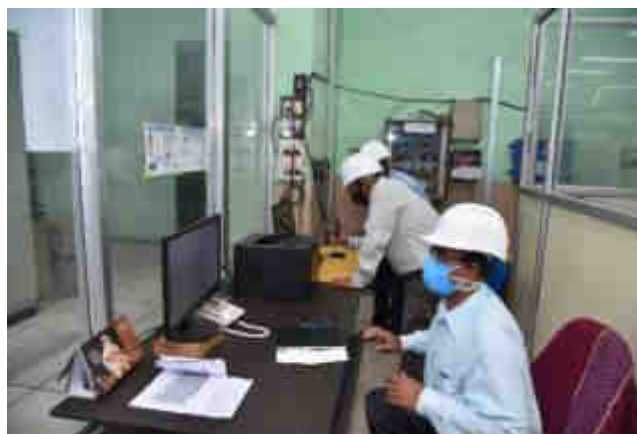
**Figure 1 Online data center**

The flue gas generated from the combustion process is discharged through a stack of suitable height via Electrostatic precipitator (ESP). Online analyzers, for the measurement of Particulate Matter, Sulphur dioxide and Oxides of Nitrogen emission have been provided for continuous monitoring and linked to the server of TNPCB & CPCB.

The effluent from the DM plant is neutralized and discharged through settling tank. The effluent from plant area is treated in a settling tank and discharged into the canal. At the discharge point, Online analyzers for Temperature, pH and Total Suspended Solids have been provided for continuous monitoring and linked to the server of TNPCB & CPCB.

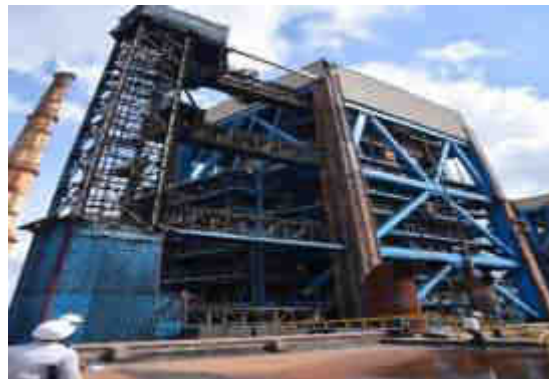
**Figure 2 Steel structure supporting Boiler**

**About the Structures:** The boiler is housed in a main steel structure made up of column and girders of box type, hollow one and all are interconnected with each other. Each box type column is 86 m height. Each box type girder is of the dimension  $L * B * H = 19.2 * 0.8 * 1.3$  to 3, meters.

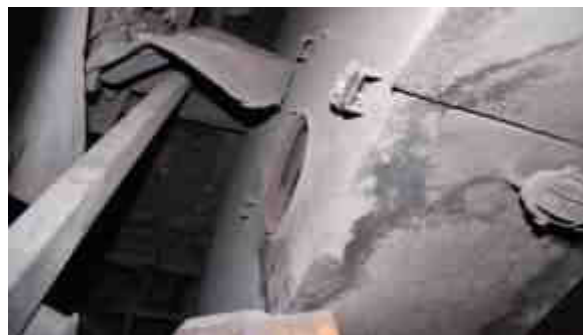
**Figure 3 Opening in the girder**

Each girder has two openings of manhole size, facing towards the boiler, round in shape, Diameter – 0.5 m at 0.75 m from the bottom & near to both the ends. Girders are at 15, 32, 44, 54, 67 & 81 meter levels (ML). The floor of each level is made of Mild steel gratings mostly and some places steel plates.

Boilers 1, 2 & 3 are same type, designed & erected by Holand company, where all the openings are closed by welding with a plate after completion of erection work. Whereas the boilers from 4 to 7 are also the same design structure but were erected by BHEL. In these case, the openings of the girders are not closed, which are left in open state. The openings might have provided to complete the erection fittings. After erection, the openings supposed to be closed

before handing over the plant. Since the openings are not visible from work area and facing towards the boiler, the openings are not noticed by the industry. Due to the earlier accident only, they came to know these openings. Found that the lignite dust was accumulated over the period of time, right from the commissioning of the plant. The dust is not removed right from the beginning. Otherwise there is no need of opening from operational aspects. That is why the same did not come to the notice of operational staff and no protocol was available for the same. The cross sectional view of structure is in the picture.

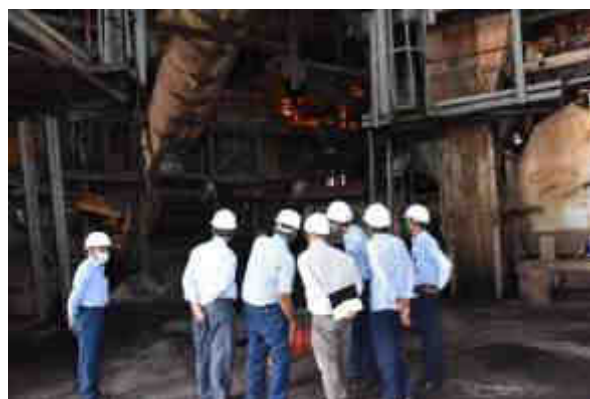
**Figure 4 Slag conveyor and bottom ash collection point**

In Unit no.:5, heavy slag discharge was observed on 29<sup>th</sup> June, 2020 throughout the night due to variation in quality of lignite, resulted in frequent tripping of slag conveyor and accumulation of slag inside the slag bath. However it is reported that they continued the intermittent operation.

To rectify the defects of bottom ash equipment, the boiler of unit – 5 was hand tripped at 09.31 hours on 30<sup>th</sup> June, 2020. Both Forced and Induced draught fans were used for forced cooling of the boiler so as to enable the maintenance team to attend the problem at the earliest. Started the various maintenance works at various work places. Out of various maintenance works, removal of lignite dust from girder was also one of them.

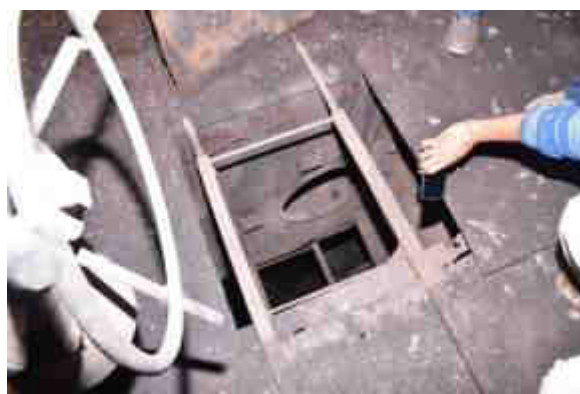
**Figure 5 Opening at 15 ML girder, where smoldering was found**

Over the period of time, probably right from the beginning of commissioning the plant, the lignite dust leaking from boiler furnace sealing gaps, resuction ducts and pulverized fuel ducts has accumulated within several horizontal legs of the girders entering through their open holes, at different levels particularly at 15ML, 32ML and 44ML girders wherein the boiler furnace zone falls.

11. The points of origin of lignite dust leakage shall be identified and suitable engineering measures shall be taken to arrest the spillages and the discharge of emission.

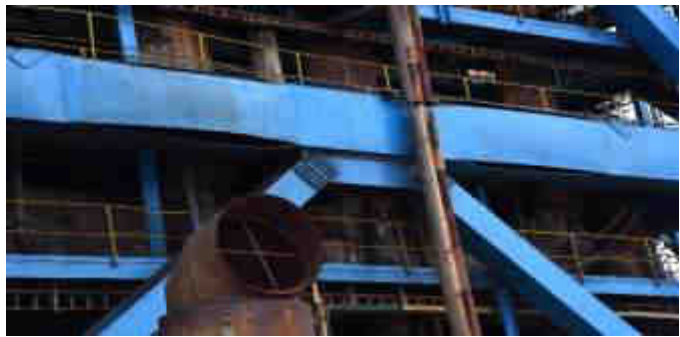
**Figure 6 Damage to the girder**

Physical damages (Deface) are found at all levels rather than burnt symptoms. No smoke stain is observed. Even though surface of nearby cable damaged but it is not burnt.

It appears that Strong wave of burst with enormous energy has been released. Heavy dust also noticed, visibility gone down and there was panic for 15 minutes. It is reported that fire put off in 35 minutes.

- c. The committee also observed damages to the structures due to rusting (28 years old plant) and blast.
- d. Accident occurred during the cleaning work. The major reason for cause of the accident may be due to Smoldering. The industry had planned to clean at 15 ML girder initially, due to smoldering/more heat, cleaning could not be carried out and subsequently cleaning was carried out in next higher level. During this activity the heat transfer from lower side (15 ML) to higher side (32 ML) might have occurred. Due to cleaning activities the fine lignite particles would have been in suspension due to manual cleaning, due to more rate of heat transfer between fine particles, might lead to process of Smoldering and caused accident.

7. For repair of box girder inside and outside by welding, adequate safety measures to be taken before allowing persons into the girders.
8. Thermal scanner shall be used to check the hotness and temperature of the girders both inside and outside before carrying out any work inside the girders to remove the lignite dust only with the supervision of NLCIL staff with the safety clearance.

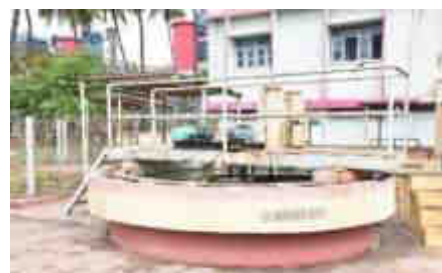
**Figure 7 STP - Clarifier tank**

The industry has been consented to discharge 100 KLD of sewage and 6225 KLD of trade effluent. The industry has provided septic tank/dispersion trench arrangements for the treatment and disposal of sewage.

The industry has also provided treatment plant for the waste water generated from the canteen and the treated waste water is disposed on land within the premises for gardening.

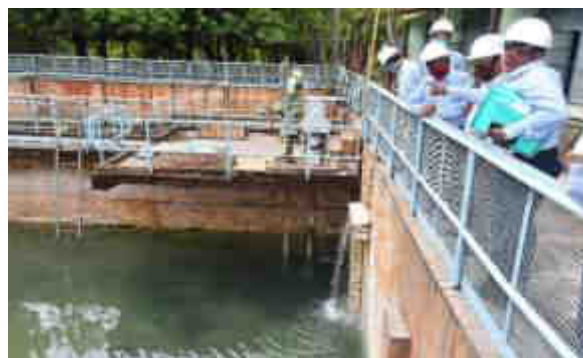
**Figure 8 Neutralization Tank**

The trade effluent generated from Demineralization plant is neutralized in neutralization tank and then treated in a settling tank along with effluent from other sources such as boiler blow down, cooling tower bleed off, floor washings, etc. The settling tank overflow is discharged into an adjacent canal.

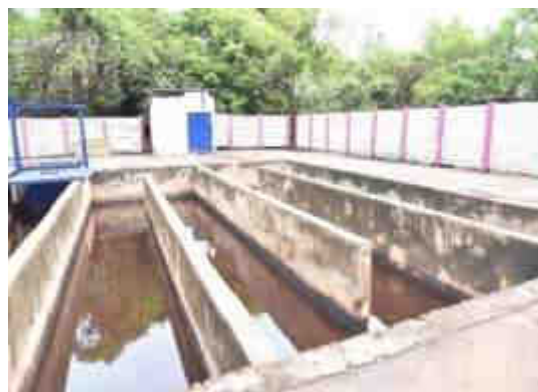
**Figure 9 Settling tank**

The trade effluent generated from Demineralization plant is neutralized in neutralization tank and then treated in a settling tank along with effluent from other sources such as boiler blow down, cooling tower bleed off, floor washings, etc. The settling tank overflow is discharged into an adjacent canal.

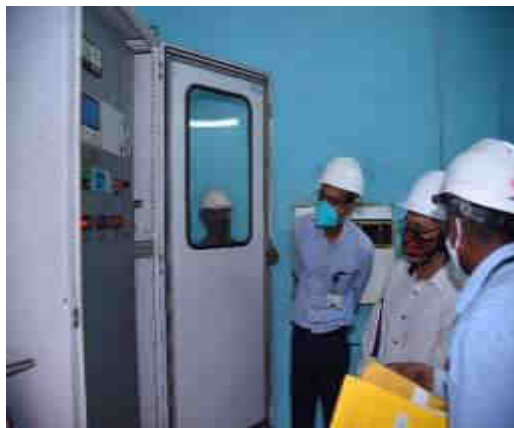
**Figure 10 Online Emission Analyzer**

The industry has provided online stack monitoring system for parameters PM, SO<sub>2</sub> and NO<sub>x</sub> and connected the same to the Care Air Centre (CAC), TNPCB, Chennai and CPCB.

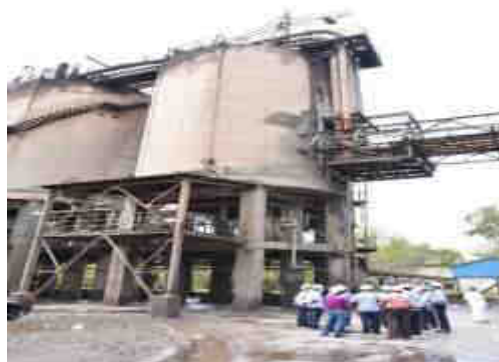
**Figure 11 Silo for fly ash collection**

The industry has provided dry fly ash collection system. The industry generates 3150 Tonnes per day of fly ash. The fly ash is disposed to cement industries and brick manufacturers. The bottom ash/slag is sent to Mine-II of NLC India Ltd for back filling in the mined area.

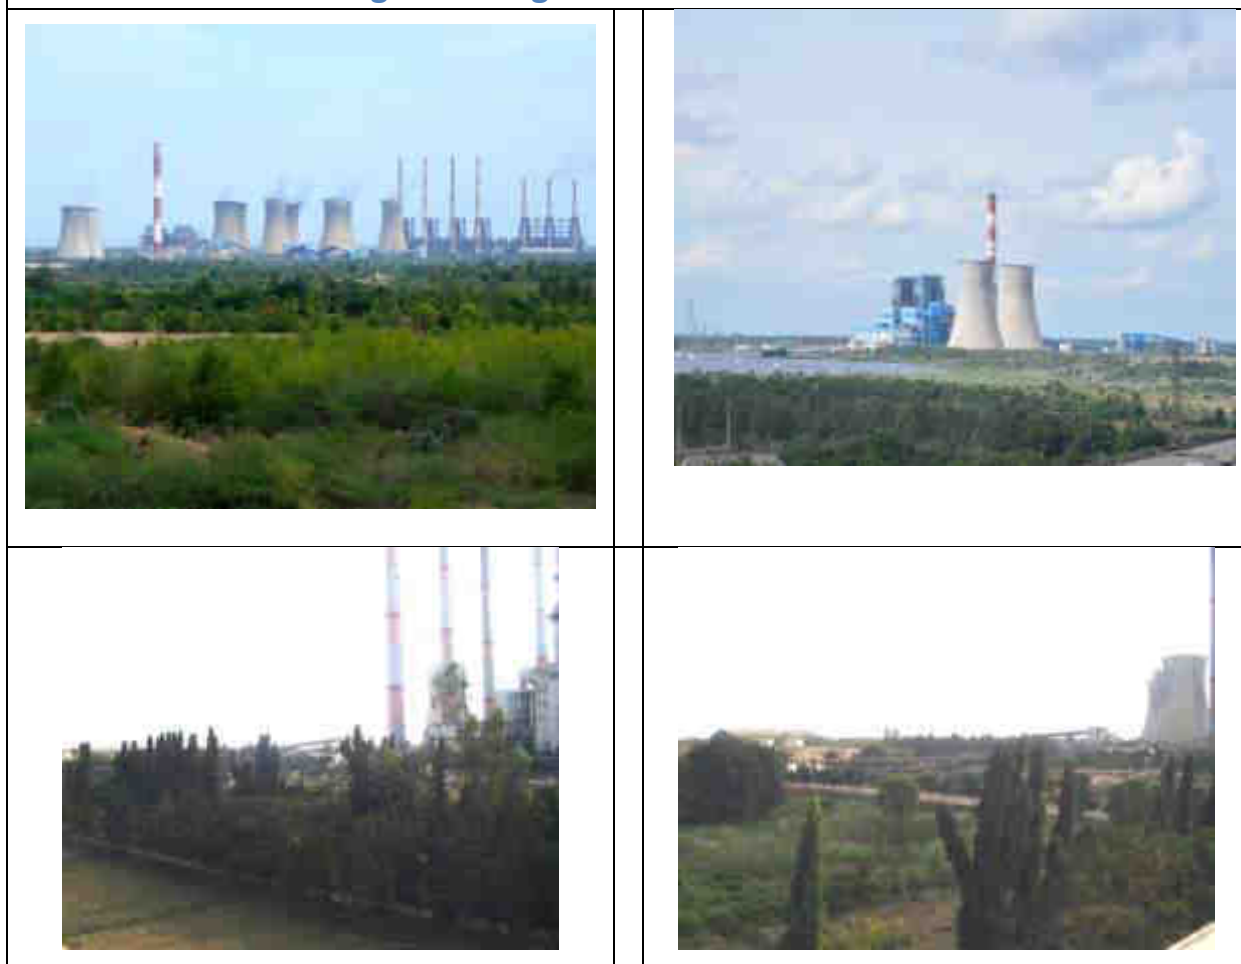
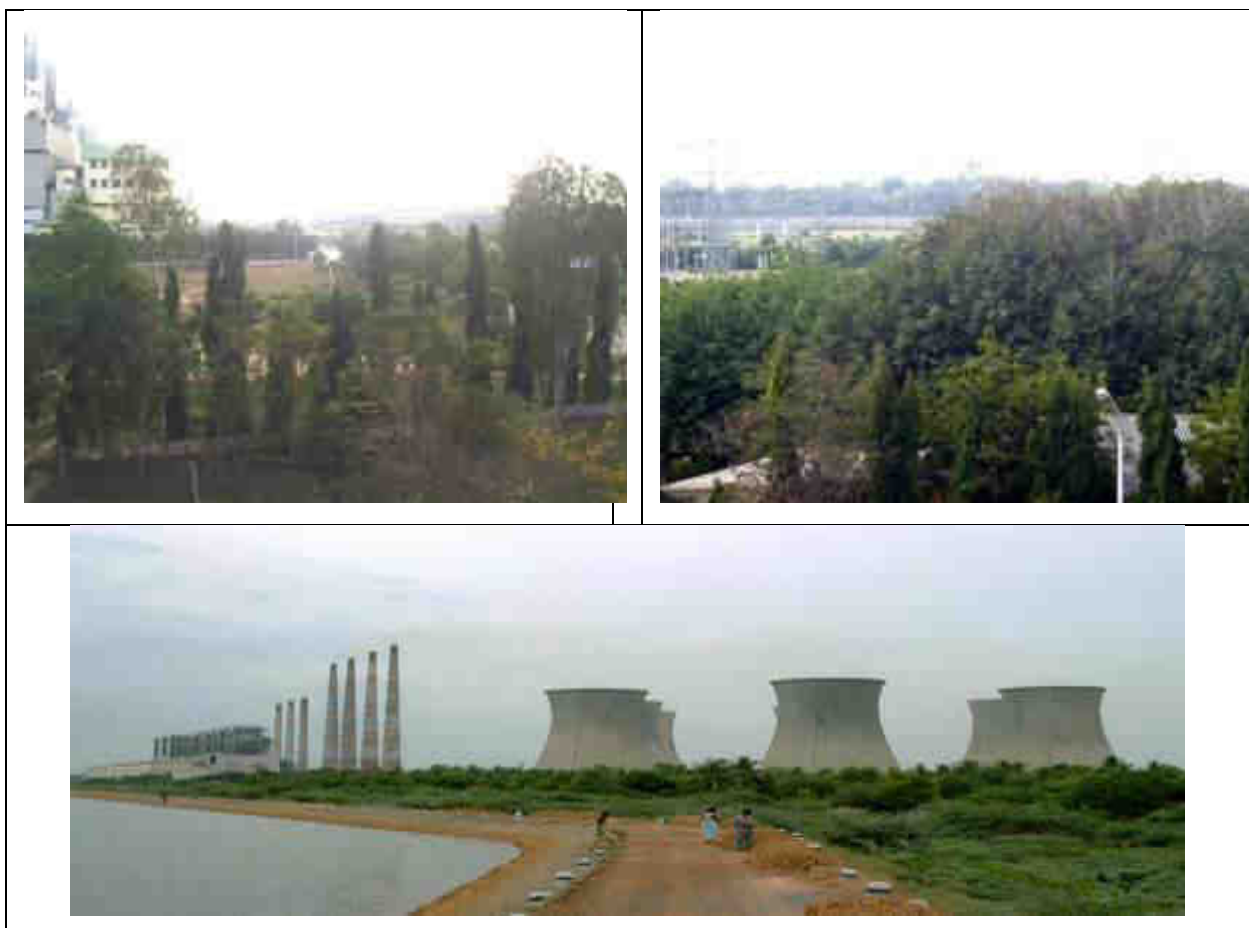
**Figure 12 vegetation around the unit**

Occurrence of healthy vegetation around the plant justifying no damage to vegetation due to this accident. No smoke stain is observed on any of the surfaces of the plant, within as well as outside of the industry premises. Further it is observed that no chance of impact on the soil and water, since the accident occurred within the girder structure from 15 to 32 m elevation, flooring of all levels is steel gratings and entire plant area is covered with concrete flooring.
